**IN THE UNITED STATES DISTRICT COURT
FOR THE SOUTHERN DISTRICT OF ALABAMA
SOUTHERN DIVISION**

ATLANTIC SPECIALTY INSURANCE COMPANY,)	
)	
)	
Plaintiff,)	
)	
vs.)	CIVIL ACTION NO. 13-458-CG-N
)	
MR. CHARLIE ADVENTURES,)	
LLC and KIM P. KORNEGAY,)	
)	
Defendant.)

ORDER

*Survey Report No: 13-IMU-0176**Report Date: September 9, 2013**Atlantic, Gulf & Pacific
Marine Surveyors and Consultants, Inc.***MARCH 8, 2013 ATTENDANCE:**

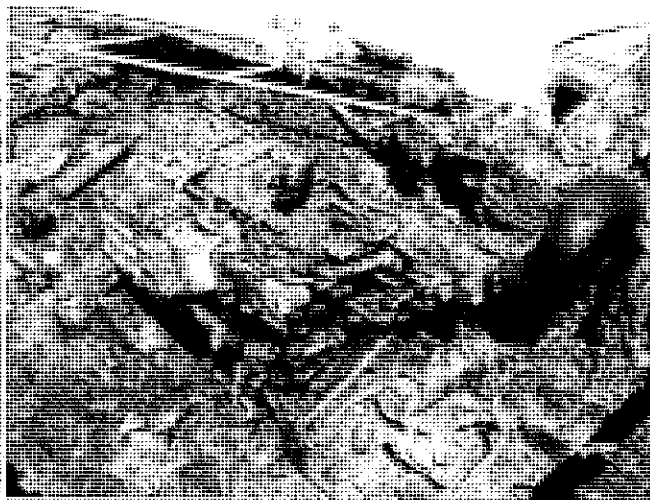
**(Stbd Main Engine Below)**

Significant melting of engine compartment aluminum components with isolated melting of copper indicative of ambient temperatures in the range of 1200°F to 1980°F, approximately. These temperature readings were one of the indicators we relied upon in formulating the initial origin area theory which also included a near total destruction of the starboard main engine fiberglass exhaust tube found in the starboard aft bilge, while the port main engine fiberglass exhaust tube was intact and whole, found aft of the port engine. (Ref: G. Jones, EFI Global June 28, 2013 Report)

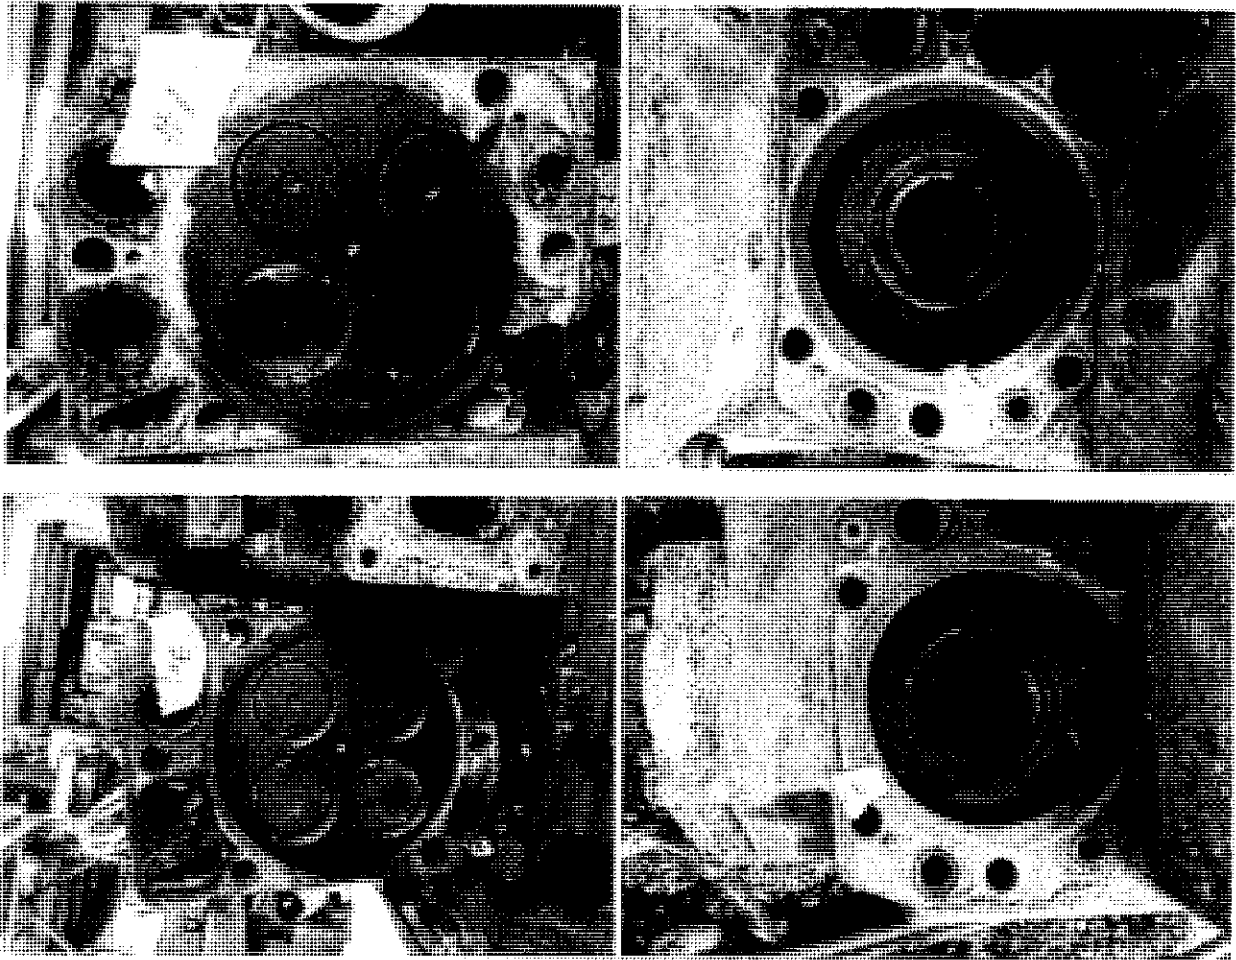
Investigations as to the cause and origin of the fire continued with the removal of the starboard main engine from the vessel which was performed by Baber Marina and then transported to Middleton Marine shop located in Orange Beach, AL for partial disassemblies on 4/18/13. Removal of cylinder heads 1-3-6, revealed no internal damage to cylinders or pistons as a result of engine overheating. (See photos below)

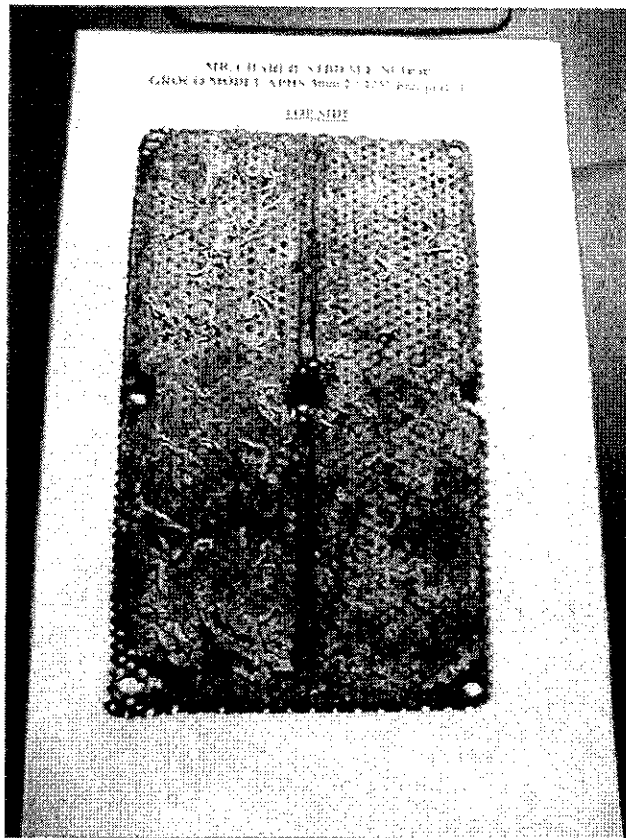
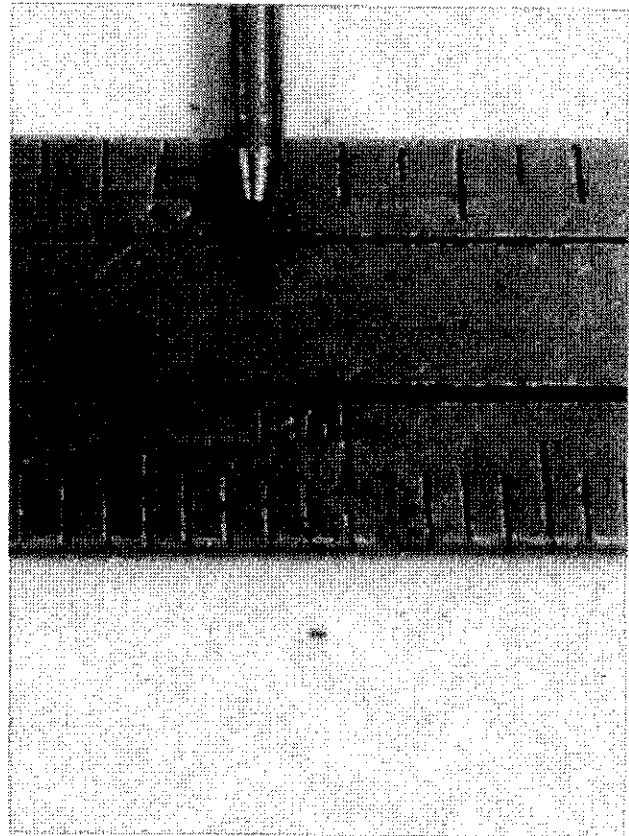
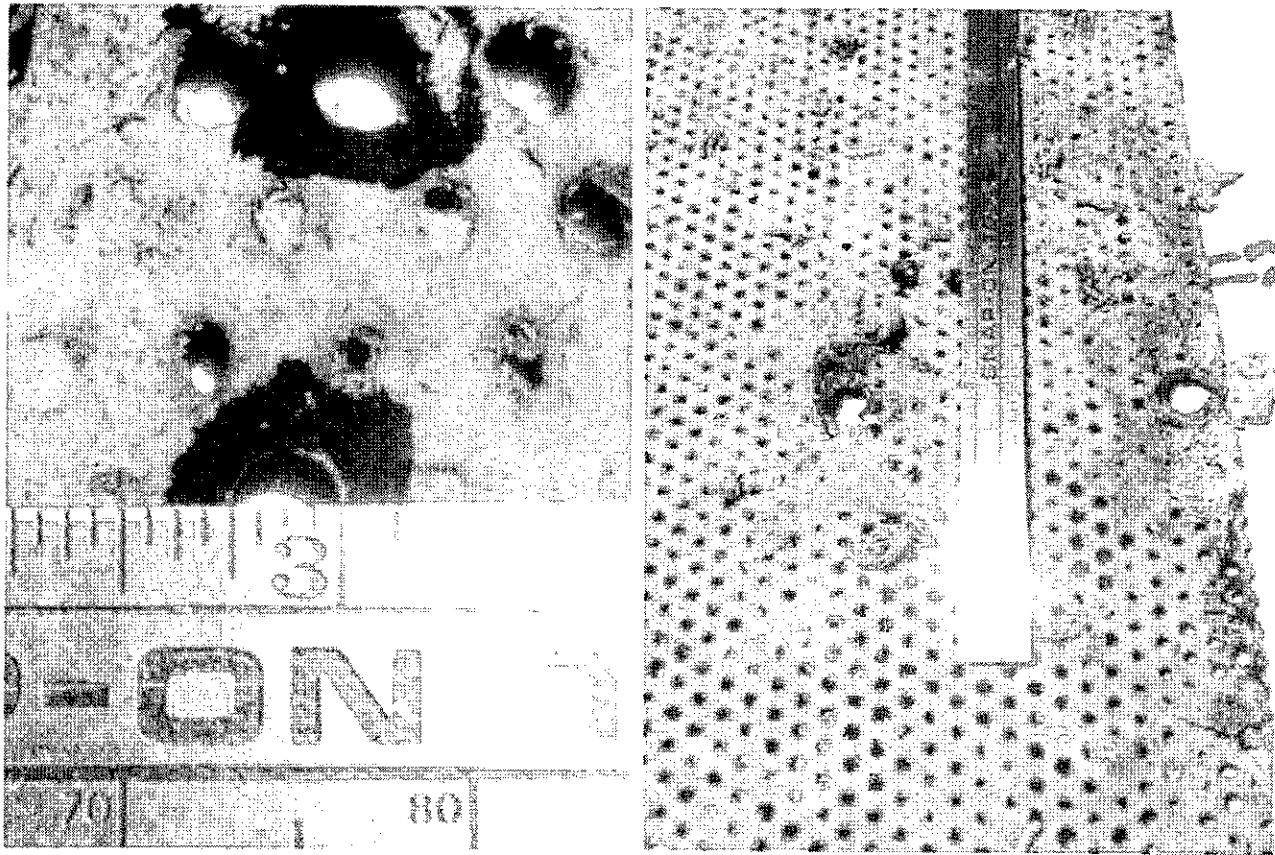
On May 7, 2013, the undersigned did conduct a close examination of both port and starboard sea scoop screens in an office environment. Both screens were photographed using various methods and angles to document the screen conditions, hole size and pattern and to illustrate the marine growth present on each.

It was determined by the undersigned that there were three (3) holes on the starboard screen which were 100% open and two (2) holes on the port screen 100% open. The sea scoops were indentified as Groco part # APHS-3000-2 bronze sea strainers. The screens were found to be manufactured by Hendrick Corporation having a Groco part #93-3000-2, stainless steel, having .125 diameter perforated holes. Both screens were found to be significantly fouled with marine growth and paint.

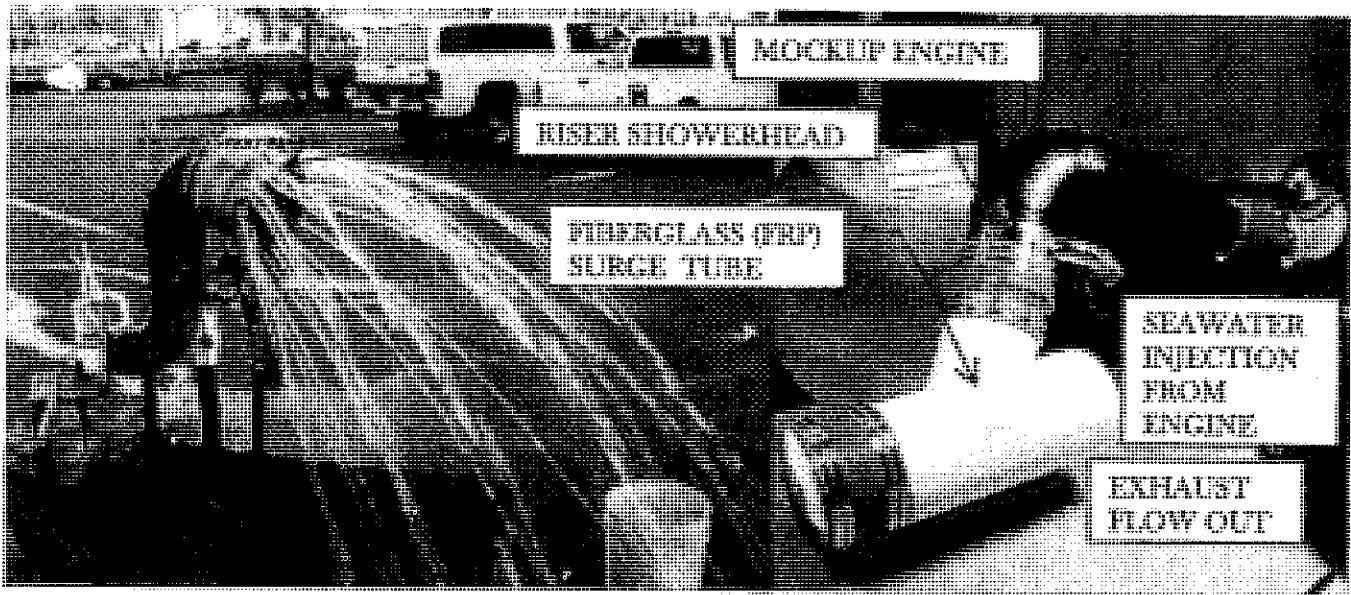
The illustration below are photos of a test stand demonstration of a stainless steel exhaust riser with water injection being applying showing how the "showerhead" on the left works and in the right photo, Marine Exhaust Systems components very similar to those installed on the MR. CHARLIE are shown with labels applied for reference.

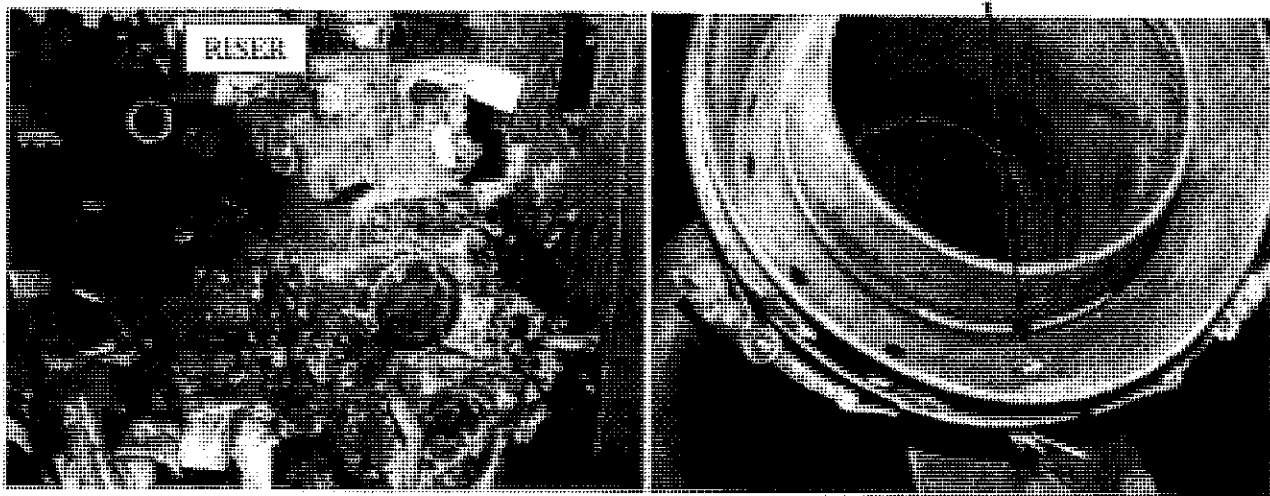
At the time of the starboard engine inspection at Middleton Marine shop located in Orange Beach, AL, the exhaust riser remained attached with both openings exposed at each end of the riser pipe once the turbocharger was removed. It was noted that one of the "showerhead" holes located at the bottom center of the ring, was plugged up with hard deposits.

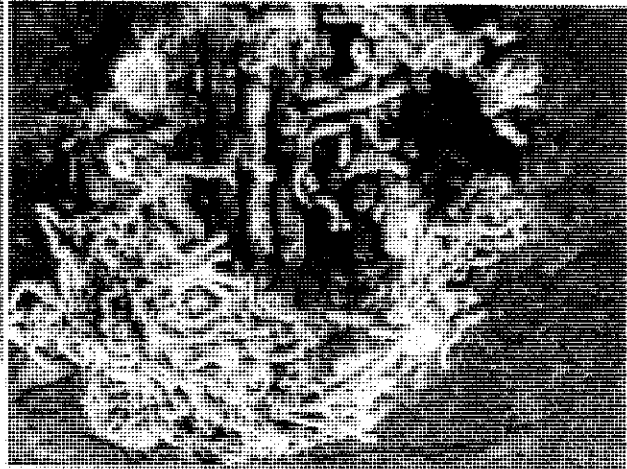
During the undersign's investigation attendances on the subject vessel beginning back on March 8, 2013, an inspection was made on all of the hull bottom and there was heavy accumulations of marine growth present with no evidence of any recent scraping on the vessel underwater running gear and or on the underwater appendages, particularly none on the main engine sea water intakes. What was obvious to me was long term marine growth that had apparently been growing since the last reported dry-docking in July 2011. (See AGP photos, Stbd Screen PDF file, Port Screen PDF file and Gulf Coast Hatteras, LLC Invoice No 360 Date 7/15/11)

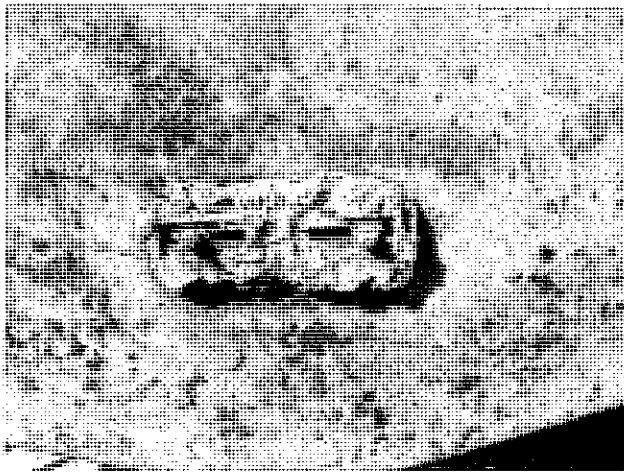
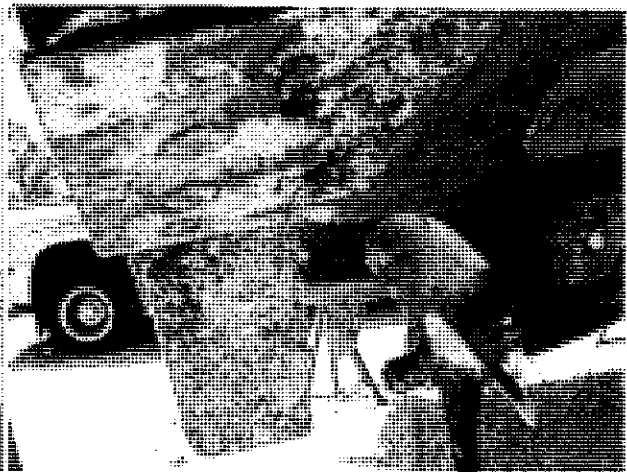
It should be noted that the propellers and lower portions of the struts were relatively clean of marine growth which is consistent with the reported "bagging" of those items performed by the owner to prevent growth from occurring. It was also noted that the anodes were mostly eaten away, deteriorated and on the rudders and propeller shafting, anodes were completely eaten away and missing.

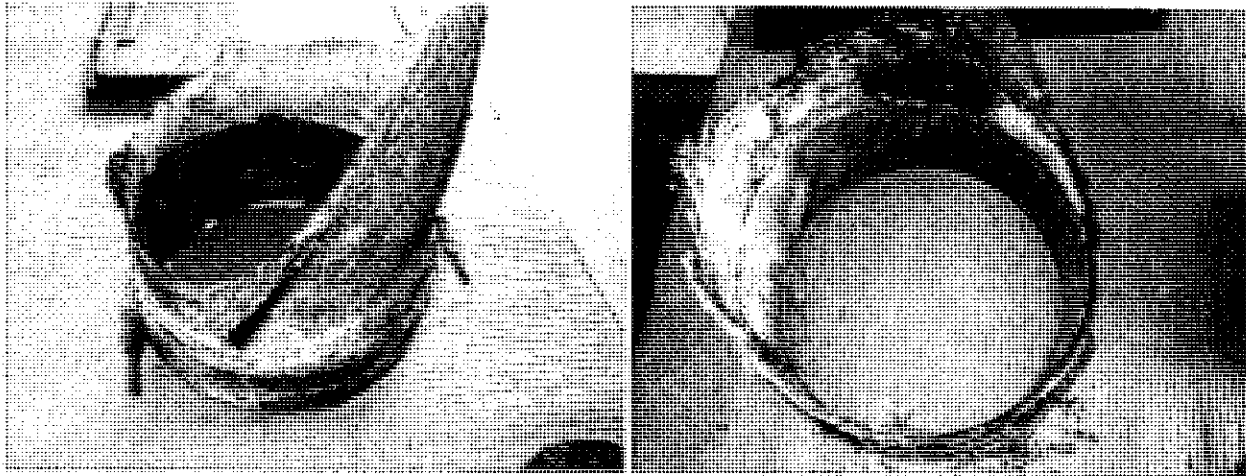
The port and starboard FRP exhaust tubes were recovered from the fire debris by the undersigned and were retained as evidence. The port FRP exhaust tube was found completely intact with some negligible burning exhibited on the outer fiberglass which is associated with the resulting surrounding fire (flames). The starboard FRP exhaust tube was found almost completely destroyed with evidence it remaining which consisted of the opposing ends of the tube (the inlet and outlet connections) for the exhaust. There was extreme consumption of the fiberglass tube, evidence a catastrophic failure of the starboard exhaust tube as a result of localized intense heat and burning (flames), and tube appeared burnt from the inside out. (Refer to AGP exhaust tube photos)
