UNITED STATES DISTRICT COURT  
DISTRICT OF CONNECTICUT

Case No. 3:11-cv-1741 (CSH)

**RULINGS ON DEFENDANT'S MOTIONS TO PRECLUDE EXPERT  
WITNESS TESTIMONY AND FOR SUMMARY JUDGMENT**

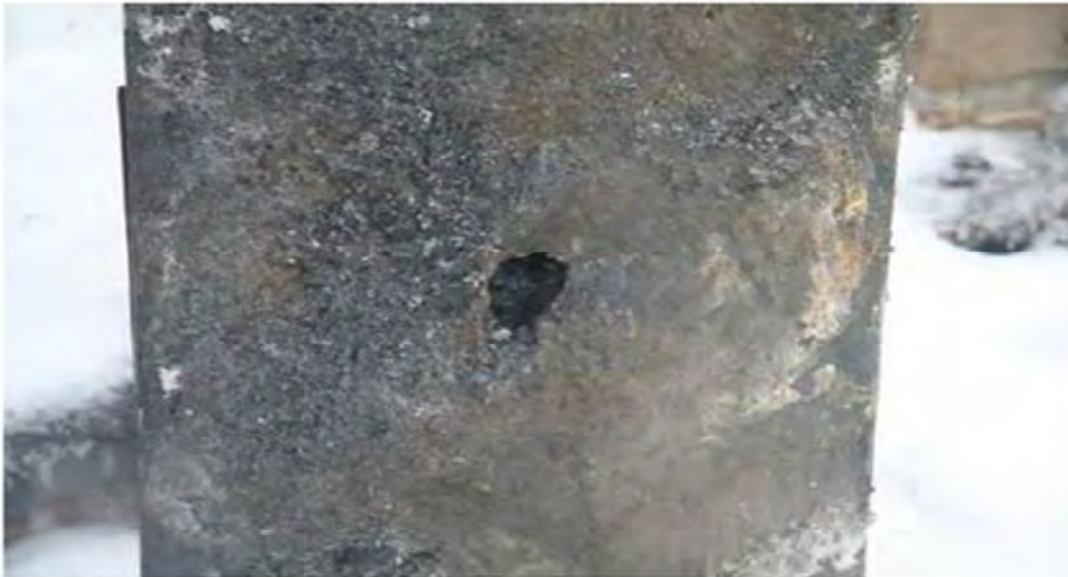
He also observed that there was a hole burned through the back of the Eaton meter panel in the location of the circuit breaker; He excluded all other potential causes for the fire. The Eaton product caused the fire.

27. Hole in exterior rear side of enclosure

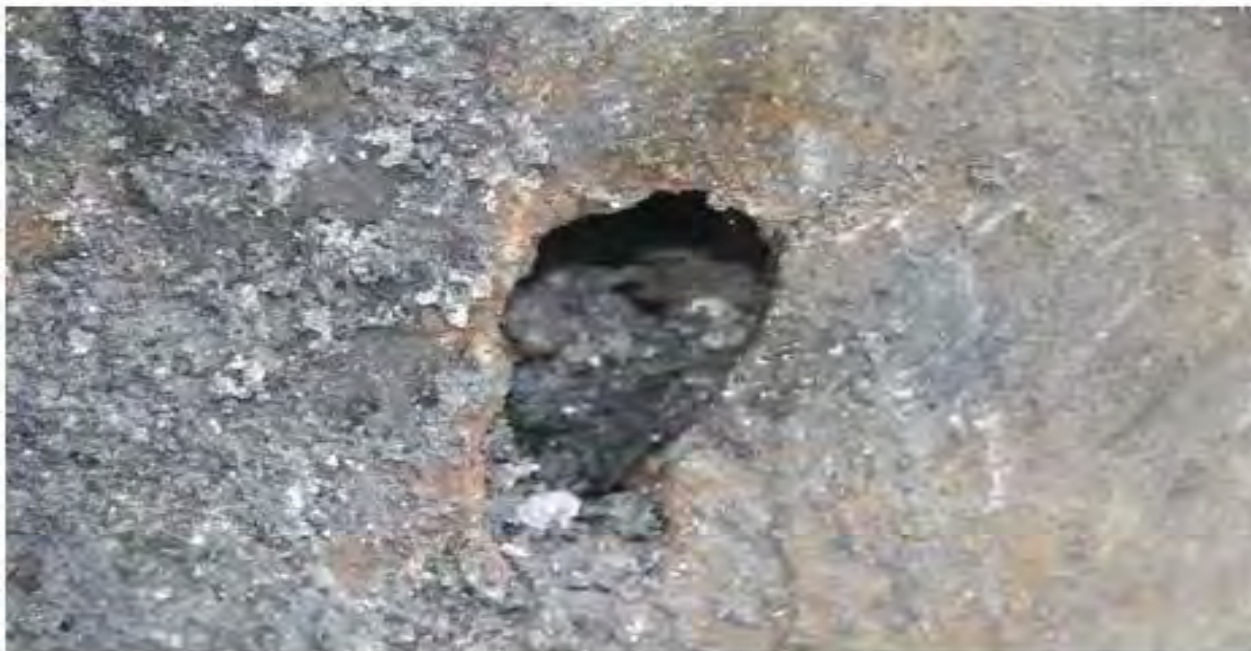
28. Closer view of hole in rear of enclosure

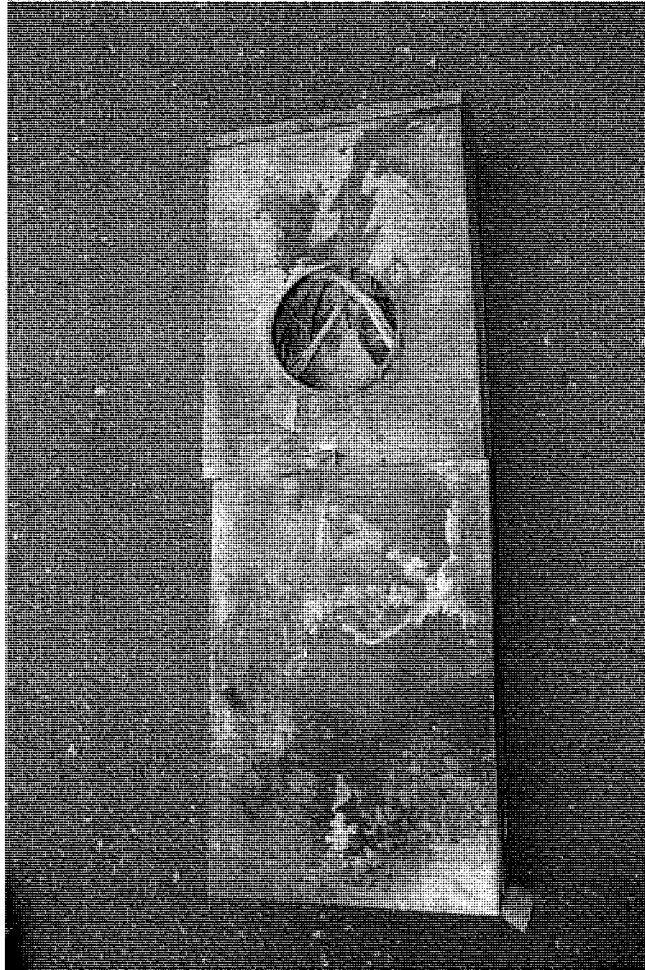
FIGURE 1. A photograph of the subject Meter/Breaker Panel. (Image No.: NEC\_1184)

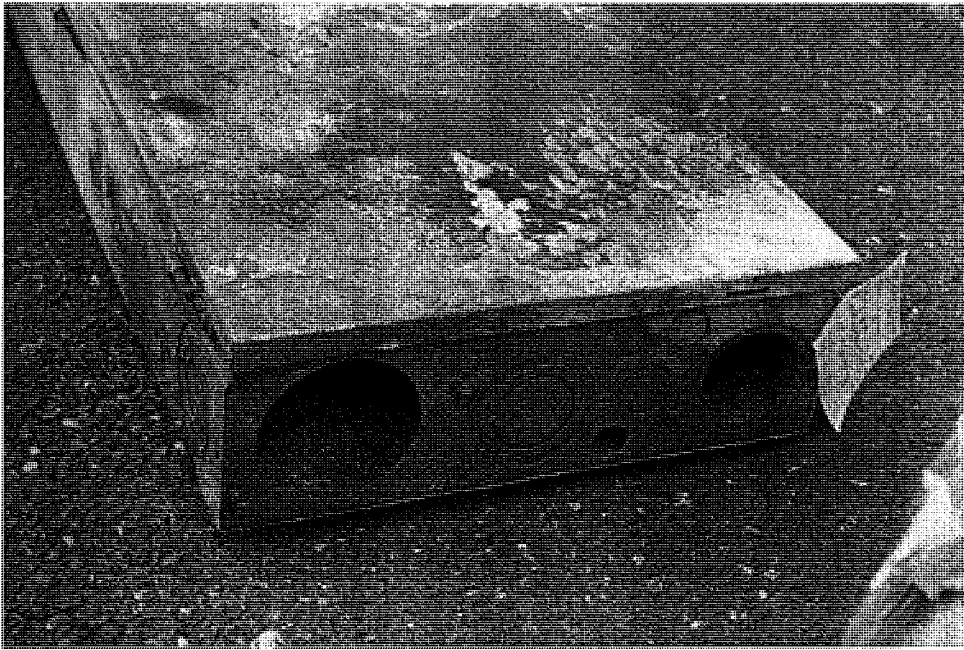
FIGURE 2. A photograph of the Lower Left Corner of the subject Meter/Breaker Panel. (Image No.: NEC\_1530)

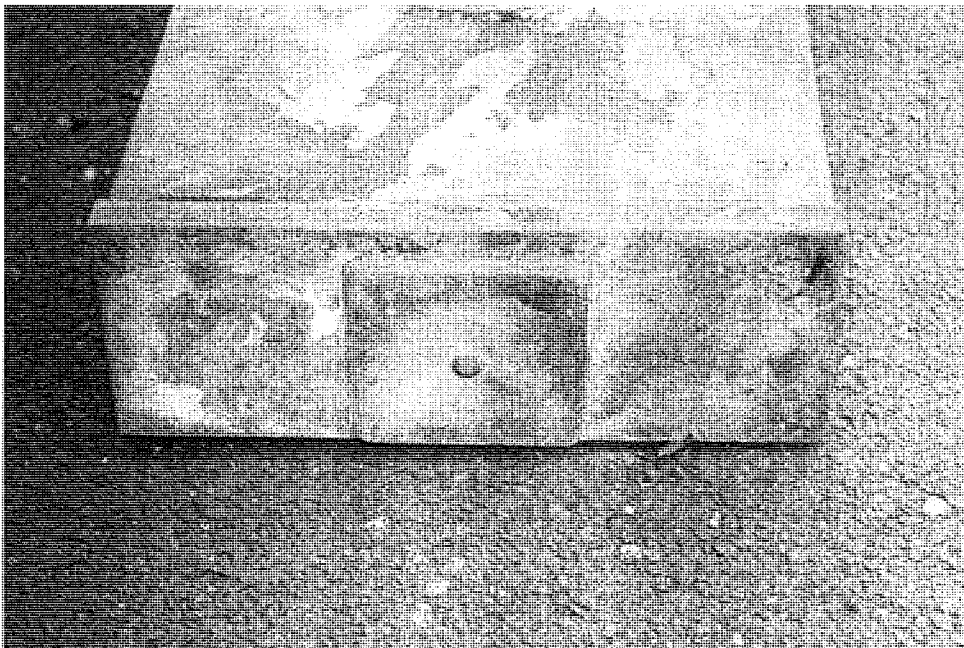
FIGURE 3. A photograph of the Top End Wall of the subject Meter/Breaker Panel. (Image No.: NEC\_1190)

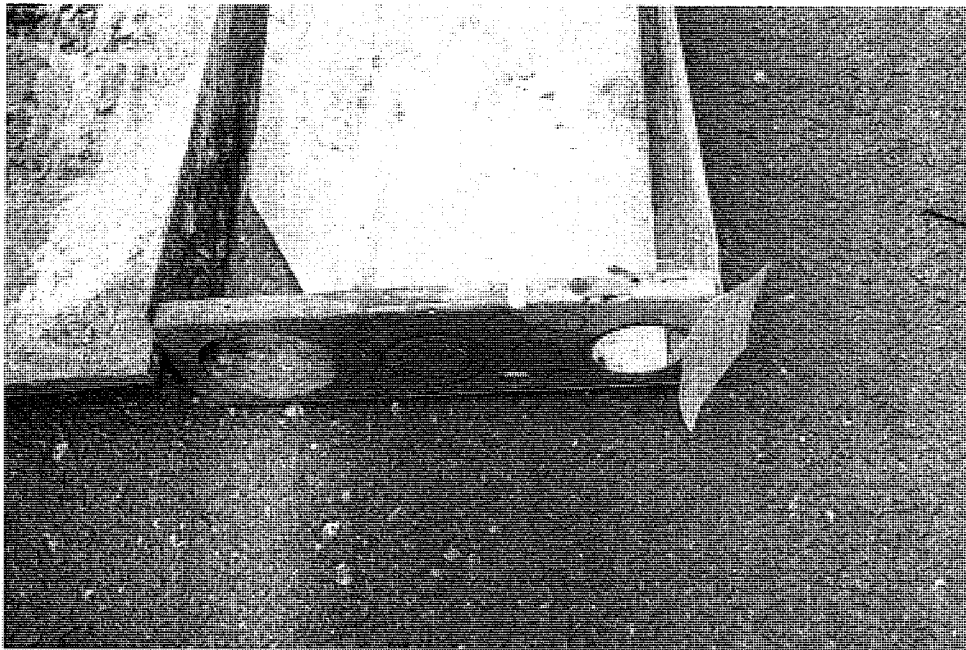
FIGURE 4. A photograph of the Bottom End Wall of the subject Meter/Breaker Panel. (Image No.: NEC\_1226)

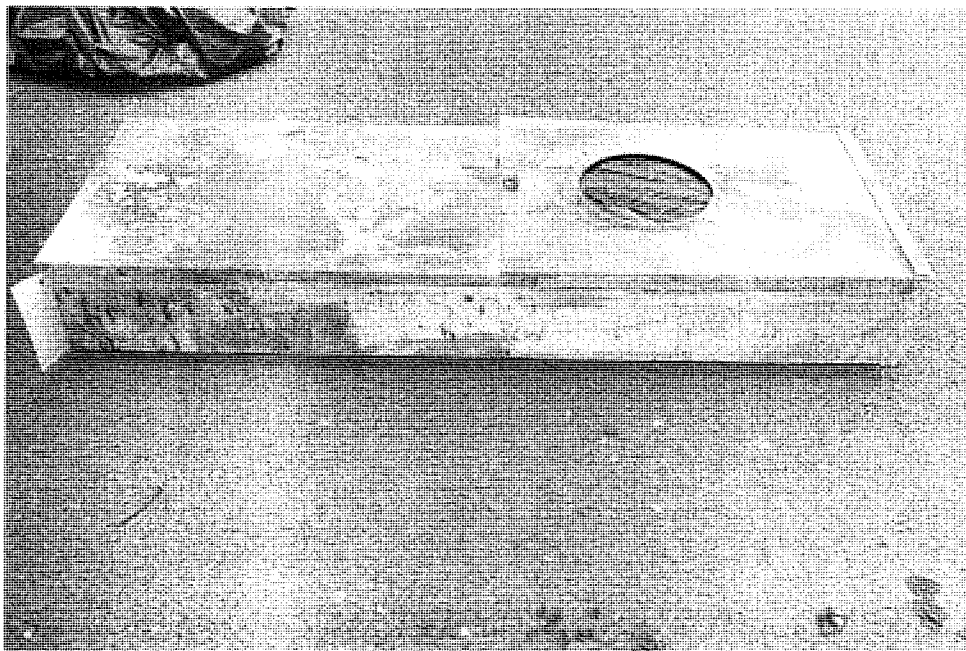
FIGURE 5. A photograph of the Right Side of the subject Meter/Breaker Panel. (Image No.: NEC\_1189)

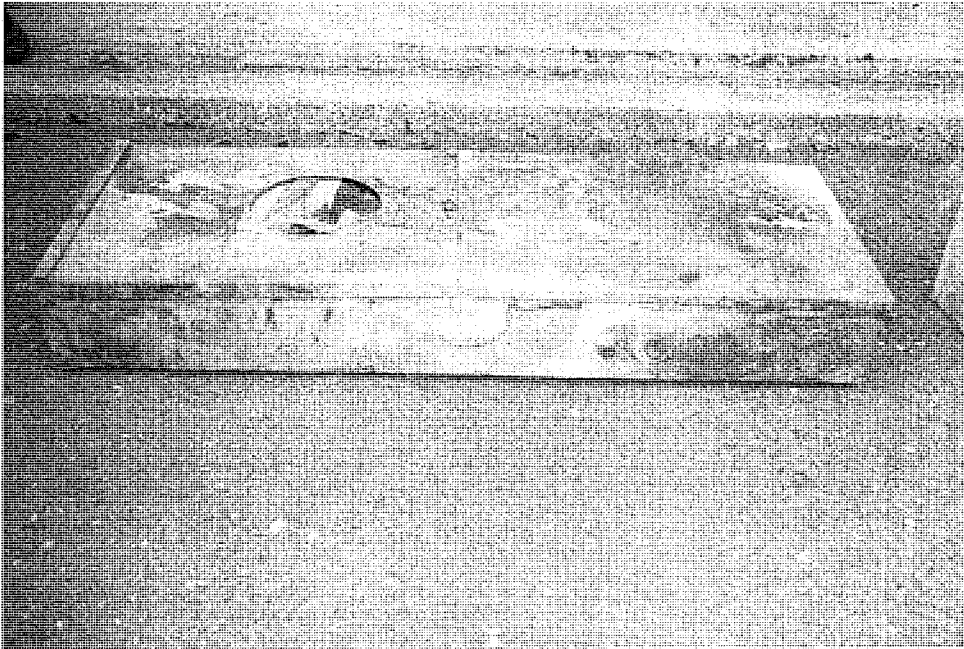
FIGURE 6. A photograph of the Left Side of the subject Meter/Breaker Panel. (Image No.: NEC\_1193)

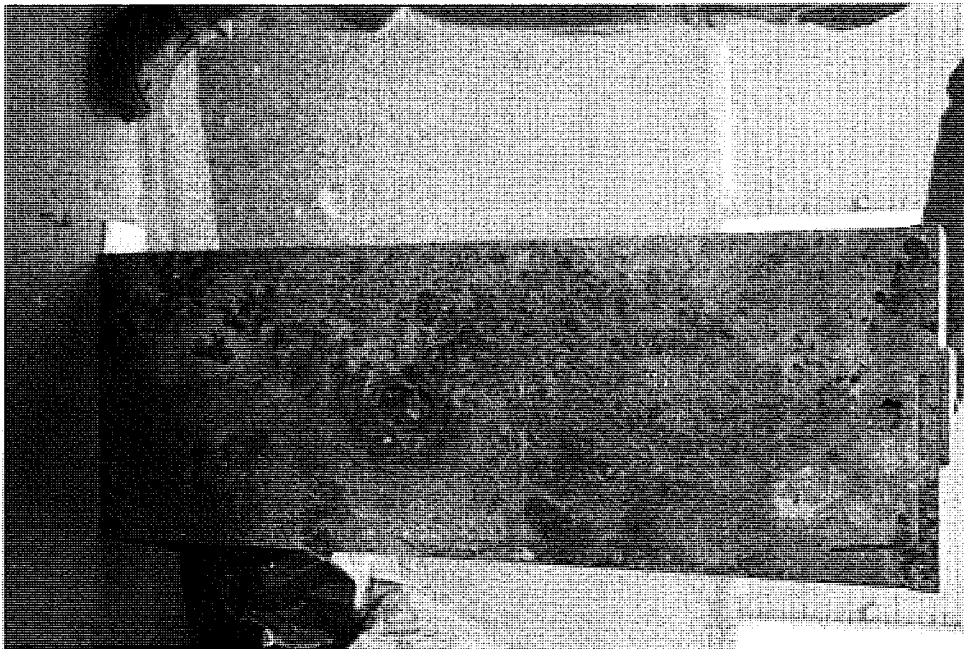
FIGURE 7. A photograph of the Rear of the subject Meter/Breaker Panel. (Image No.: NEC\_1715)

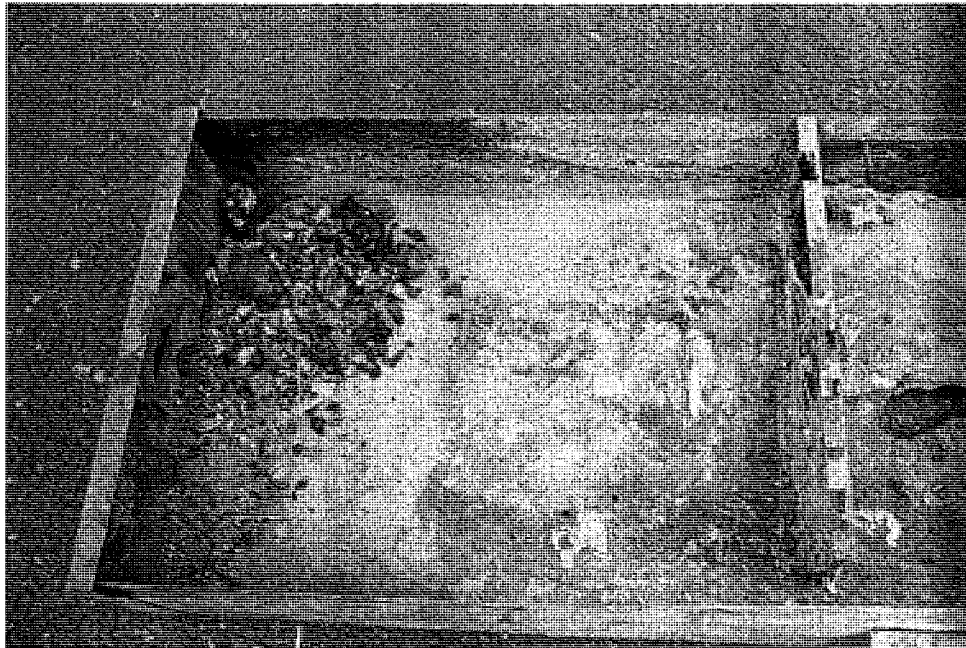
FIGURE 10. A photograph of the interior enclosure of the Meter Compartment for the subject Meter/Breaker Panel. (Image No.: NEC\_1298)

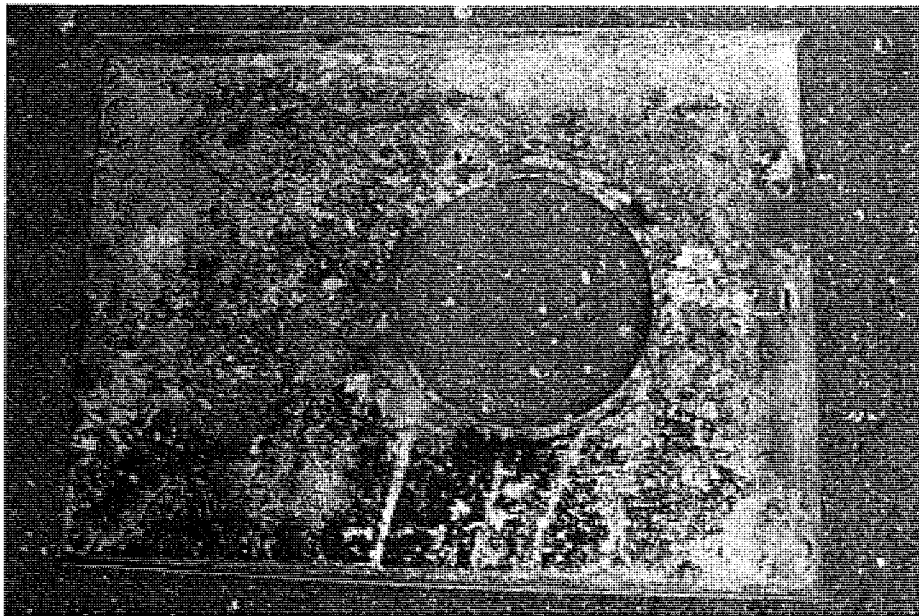
FIGURE 12. A photograph of the interior surface of the subject Meter Cover for the subject Meter/Breaker Panel. (Image No.: 7443J-133)

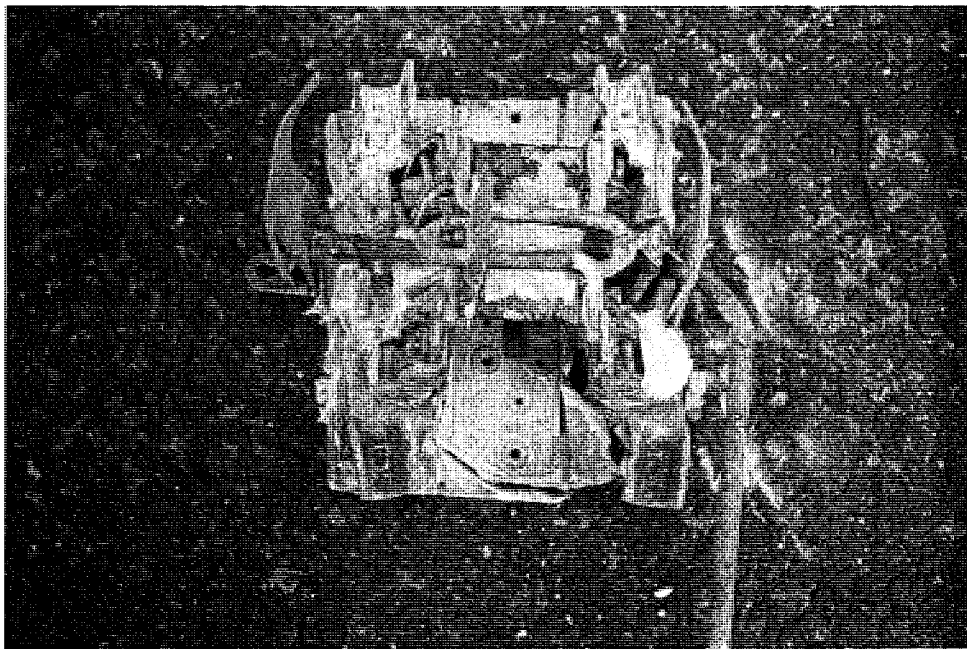
FIGURE 13. A photograph of the front of the subject Utility Meter for the subject Meter/Breaker Panel. (Image No.: NEC\_1740)

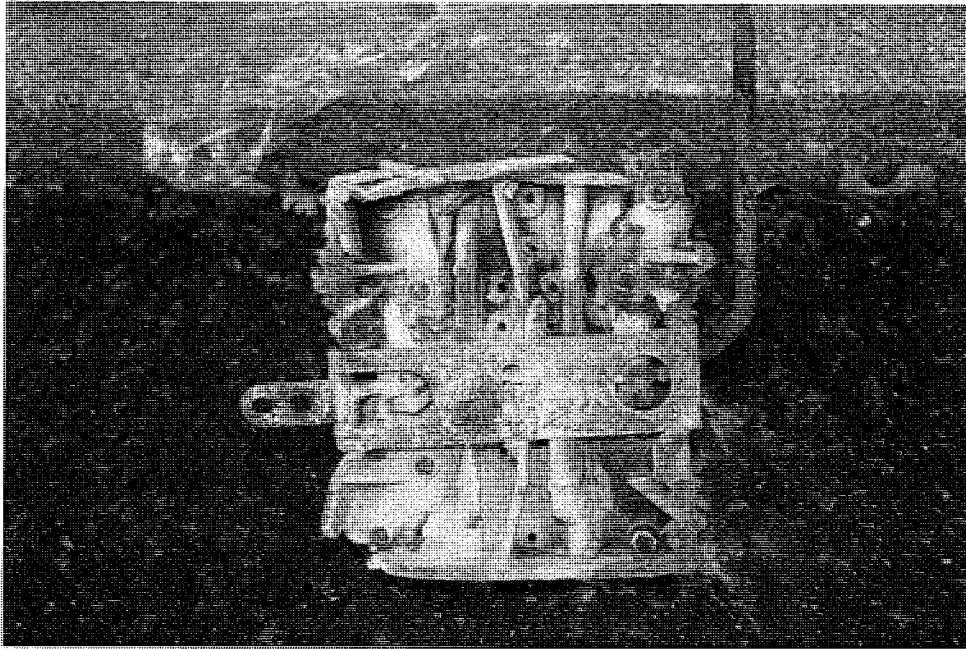
FIGURE 14. A photograph of the meter base of the subject Utility Meter for the subject Meter/Breaker Panel. (Image No.: NEC\_1757)

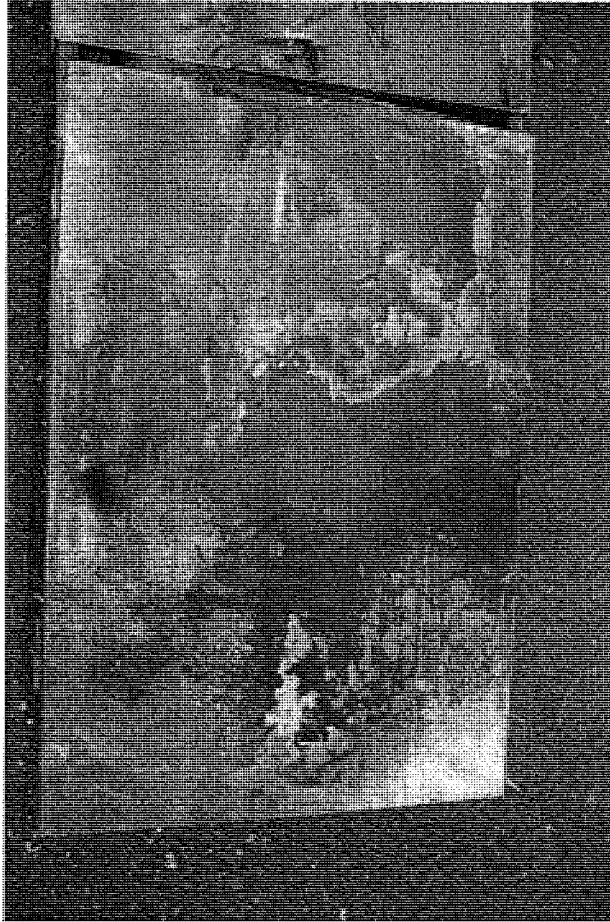
FIGURE 15. A photograph of the Breaker Compartment for the subject Meter/Breaker Panel.  
(Image No.: NEC\_1202)

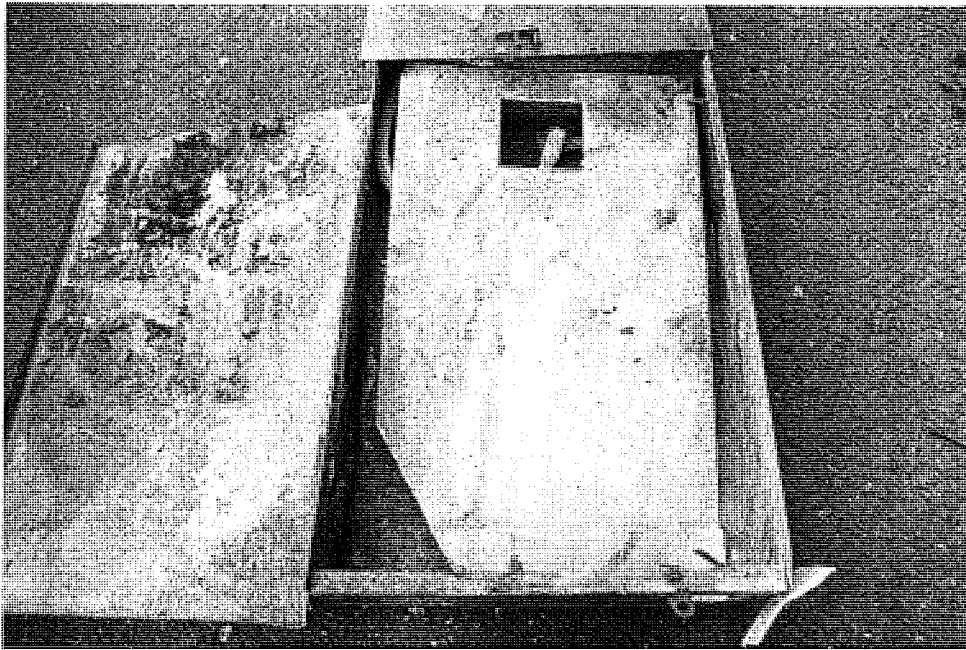
FIGURE 16. A photograph of the Interior View of the Breaker Compartment for the subject Meter/Breaker Panel with the subject Deadfront Cover positioned over the Breaker Compartment. (Image No.: NEC\_1234)

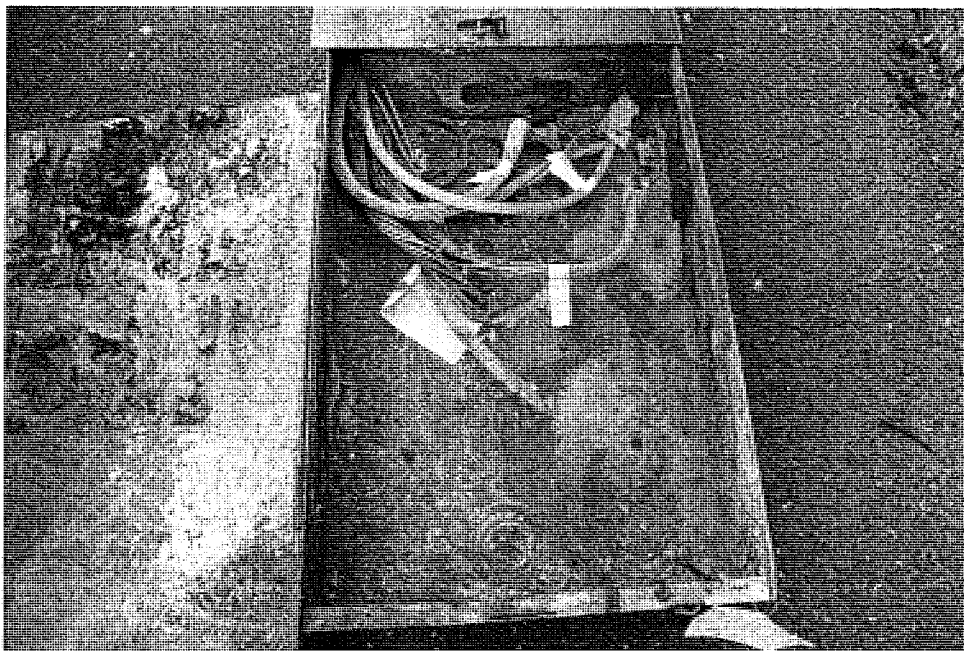
FIGURE 17. A photograph of the Interior View of the Breaker Compartment for the subject Meter/Breaker Panel with the subject Deadfront Cover removed from the Breaker Compartment. (Image No.: NEC\_1250)

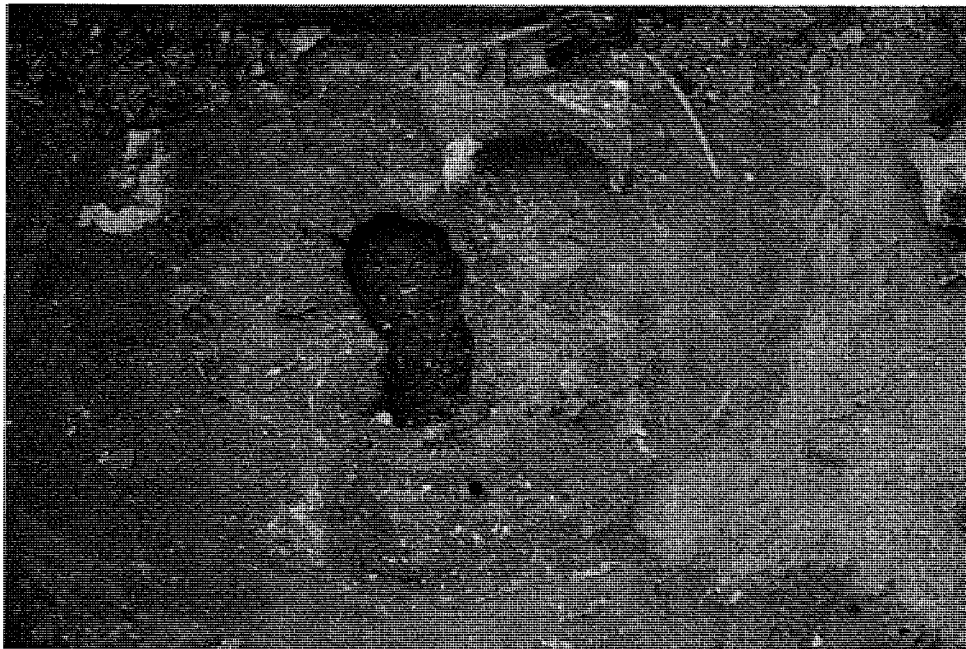
FIGURE 18. A photograph of the Oval Shaped Opening created by Electrical Fault Activity that was evident within the Interior Enclosure of the Breaker Compartment for the subject Meter/Breaker Panel. (Image No.: NEC\_1310)

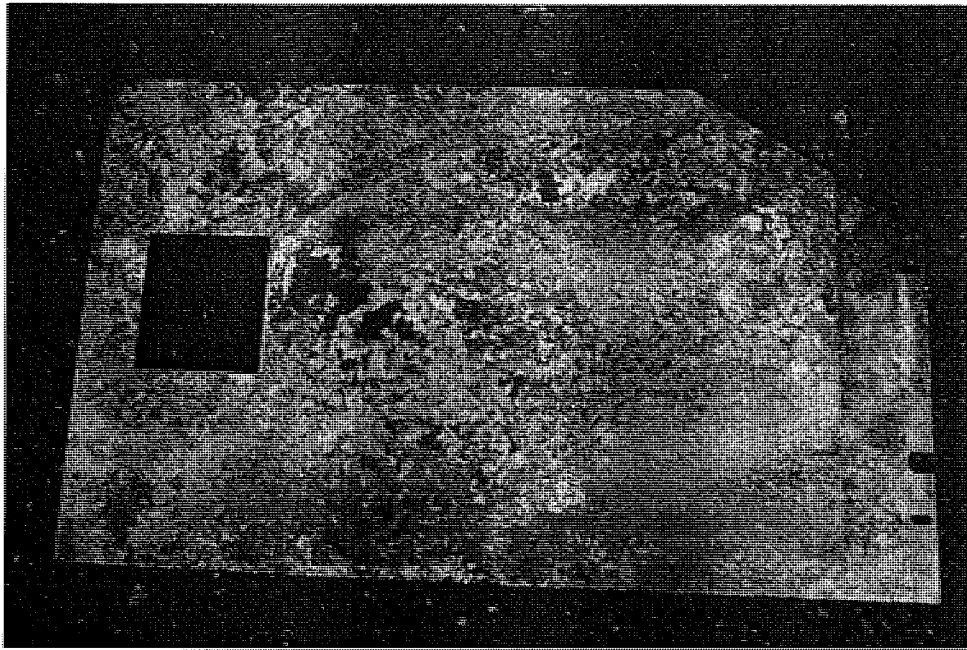
FIGURE 20. A photograph of the interior surface of the subject Deadfront Cover for the Breaker Compartment of the subject Meter/Breaker Panel. (Image No.: NEC\_1242)

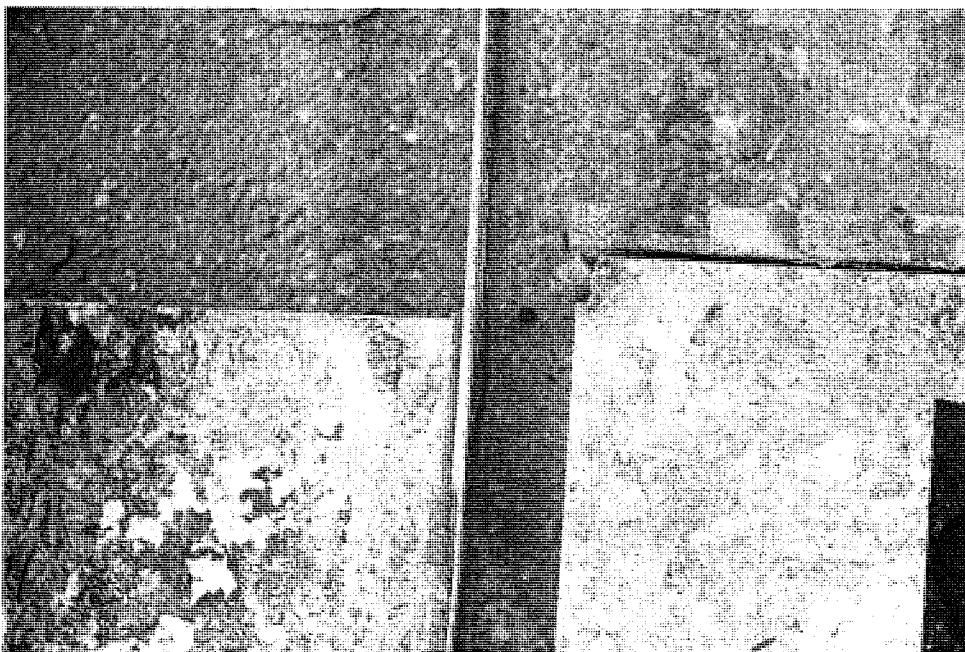
FIGURE 21. A photograph of the electrical fault activity present at the upper left corner for the subject Deadfront Cover for the Breaker Compartment positioned near the subject Barrier of the subject Meter/Breaker Panel. (Image No.: NEC\_1414)

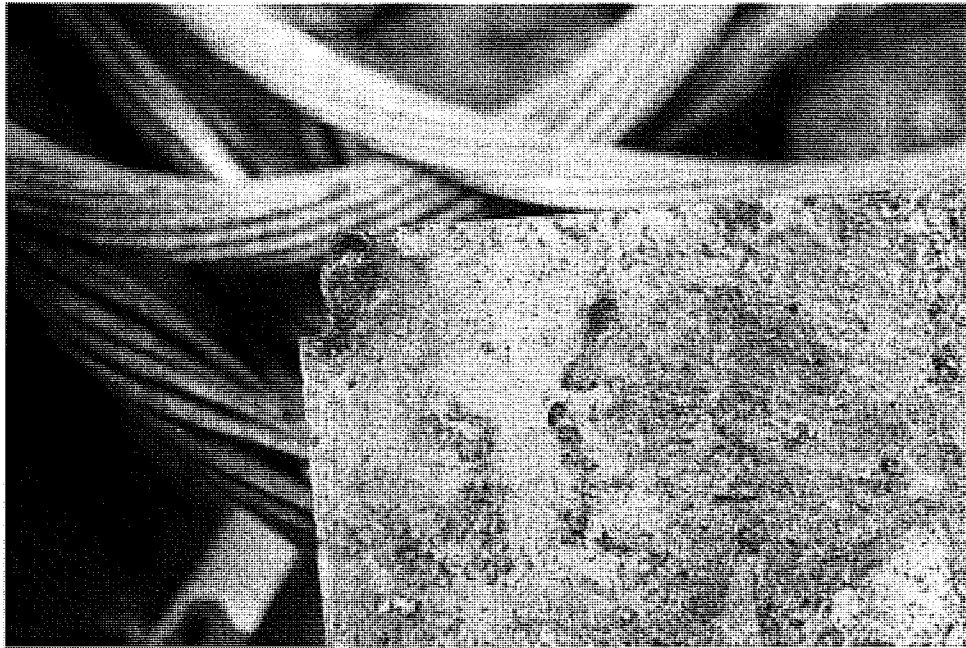
FIGURE 22. A photograph of the Electrical Fault Activity observed at the upper left corner of the subject Deadfront Cover for the Breaker Compartment of the subject Meter/Breaker Panel. (Image No.: NEC 1239)

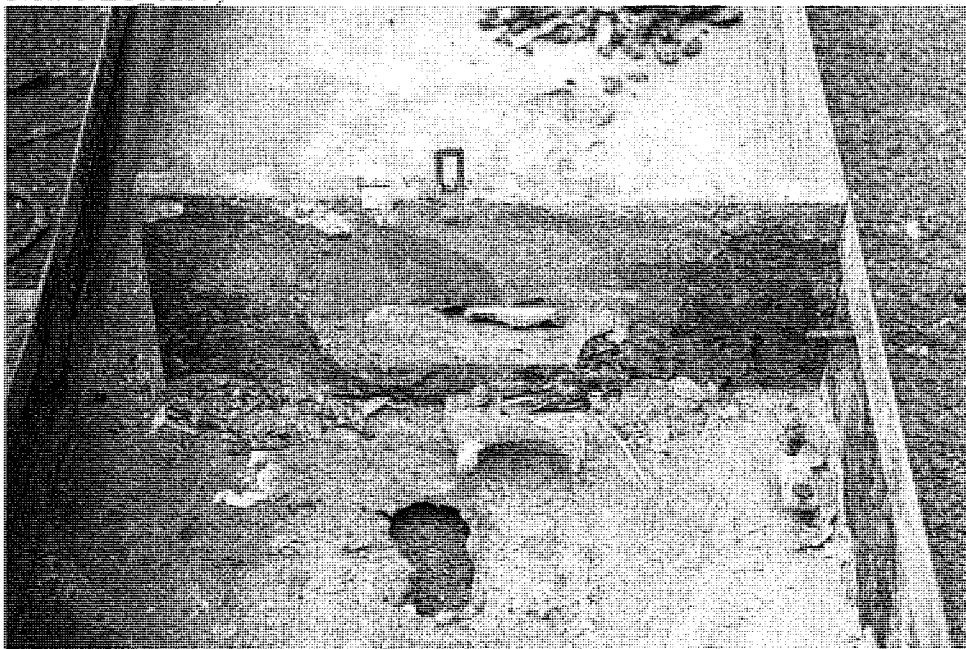
FIGURE 23. A photograph of the subject Barrier between the Meter Compartment and the Breaker Compartment within the Housing of the subject Meter/Breaker Panel. (Image No.: NEC\_1301)

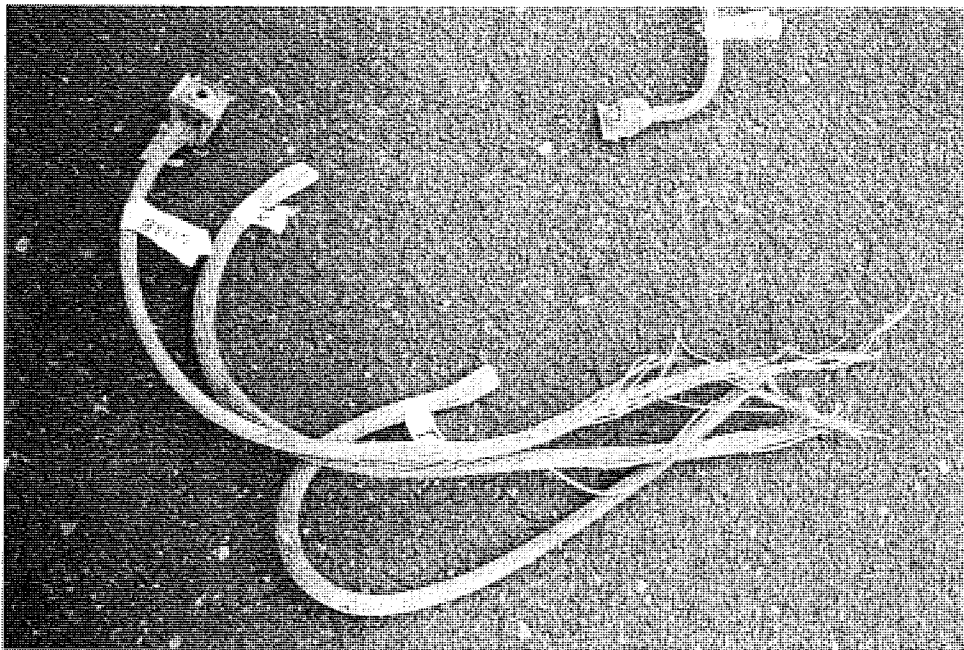
FIGURE 25. A photograph of the conductors for the subject Utility Cable for the subject Meter/Breaker Panel. (Image No.: NEC\_1496)

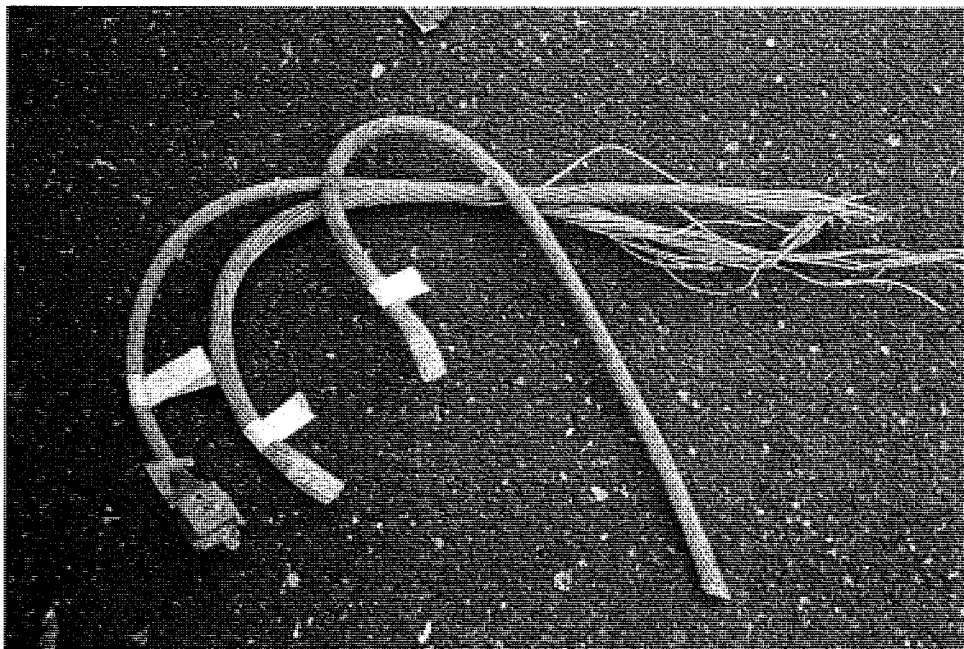
FIGURE 26. A photograph of the subject Conductor for the subject Utility Cable for the subject Meter/Breaker Panel. (Image No.: NEC\_1500)

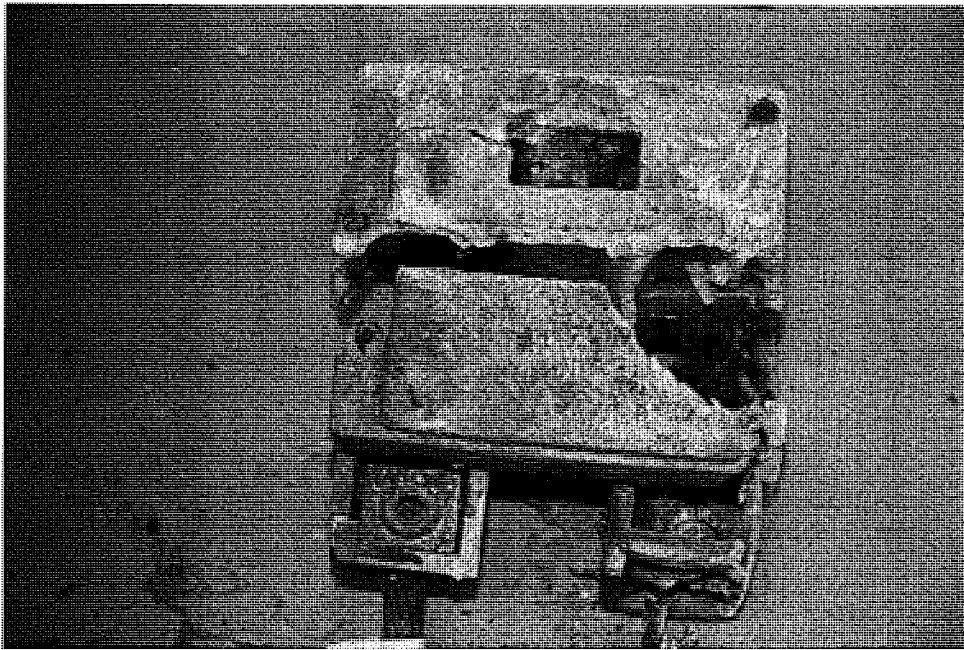
FIGURE 27. A photograph of the subject Circuit Breaker from the subject Meter/Breaker Panel. (Image No.: NEC\_3921)

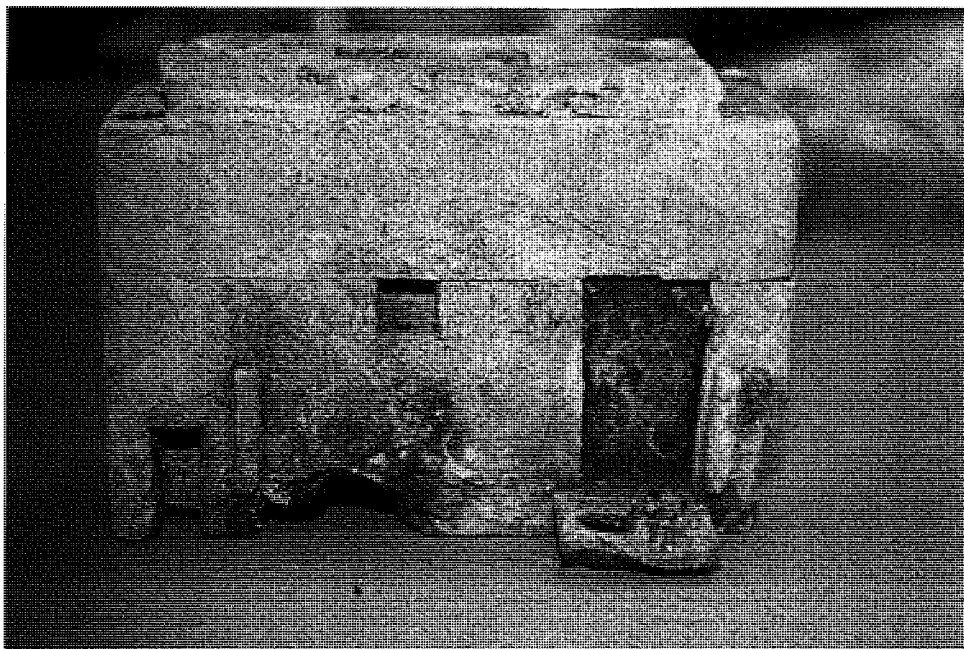
FIGURE 28. A photograph of the Load Side of the subject Circuit Breaker from the subject Meter/Breaker Panel. (Image No.: NEC\_3699)

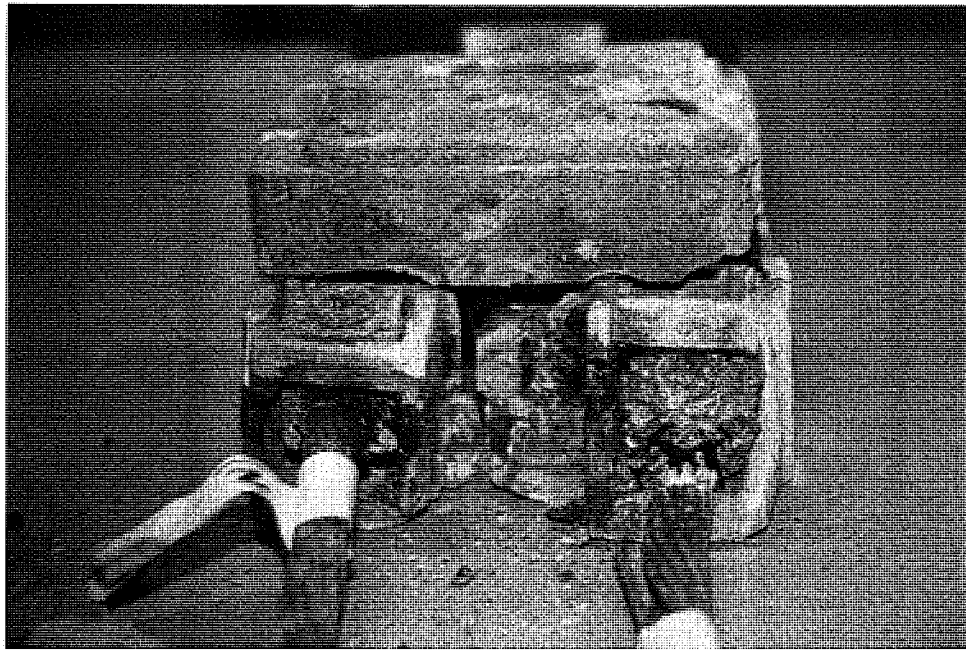
FIGURE 29. A photograph of the Line Side of the subject Circuit Breaker from the subject Meter/Breaker Panel. (Image No.: NEC\_3915)

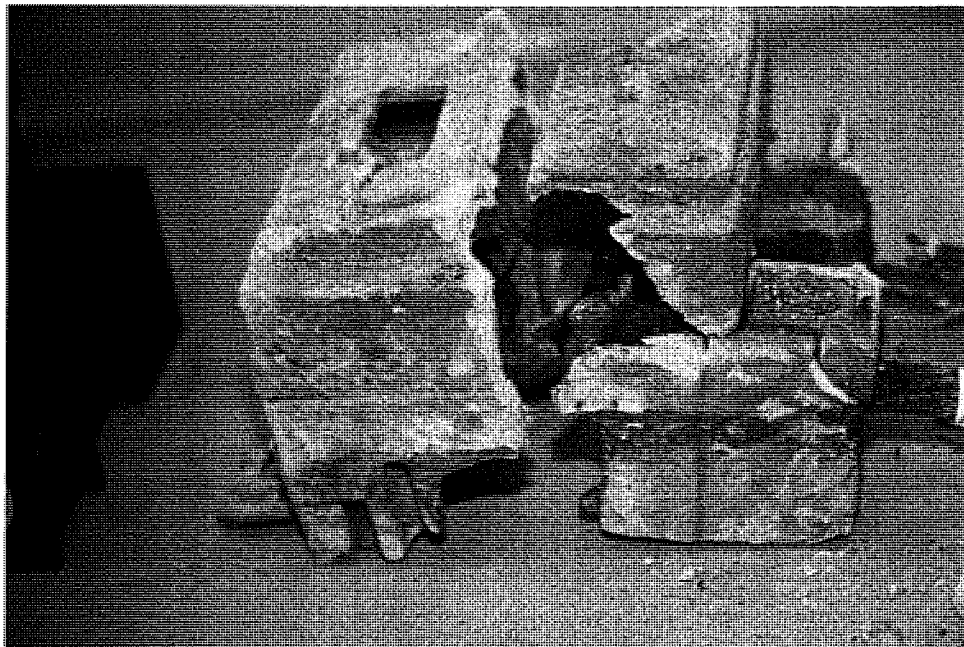
FIGURE 30. A photograph of the view of the Right Side of the subject Circuit Breaker from the subject Meter/Breaker Panel. (Image No.: NEC\_3918)

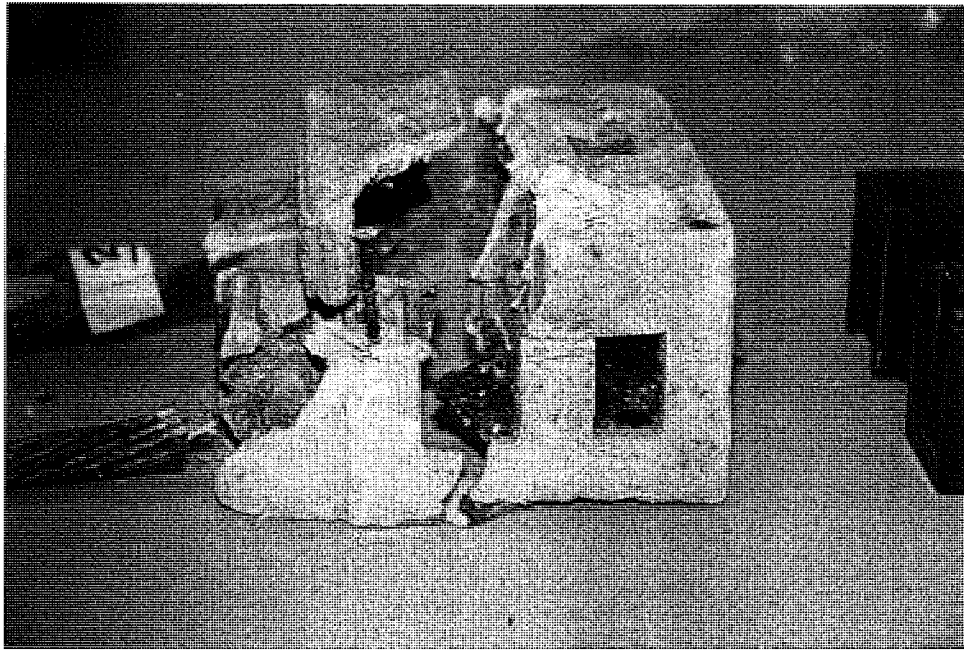
FIGURE 31. A photograph of the view of the Left Side of the subject Circuit Breaker from the subject Meter/Breaker Panel. (Image No.: NEC\_3920)

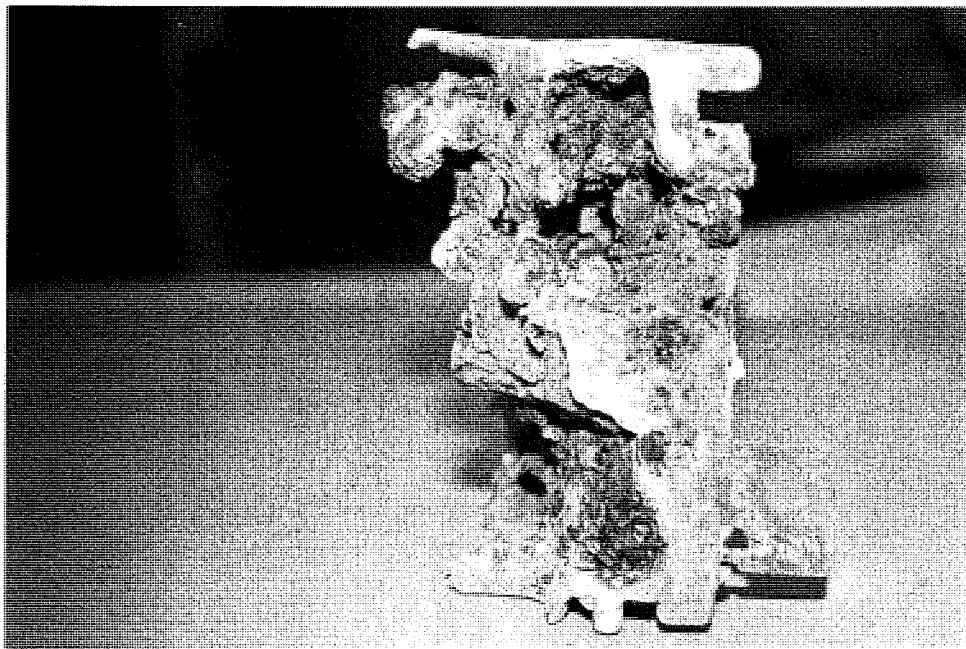
FIGURE 32. A photograph of the view of the Bottom Side of the subject Circuit Breaker from the subject Meter/Breaker Panel. (Image No.: NEC\_3730)

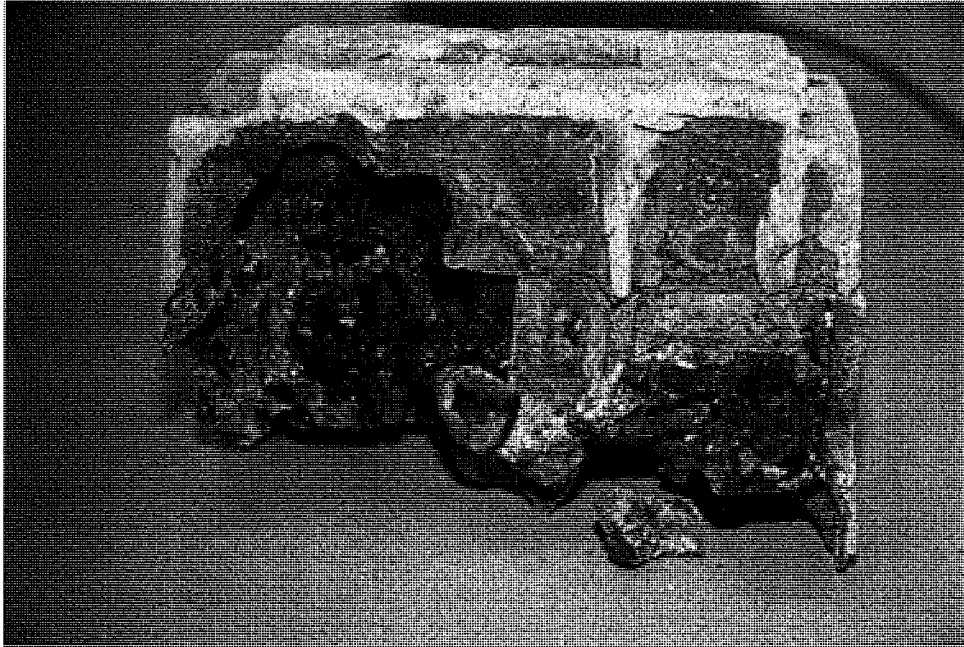
FIGURE 33. A photograph of the view of the Interior of the subject Circuit Breaker from the subject Meter/Breaker Panel. (Image No.: NEC\_3783)

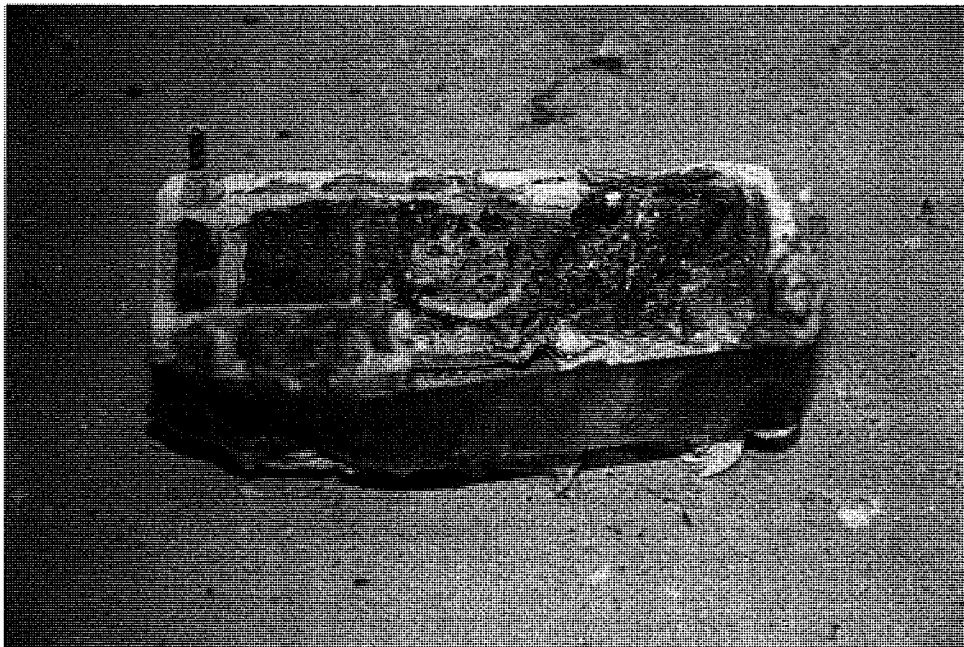
FIGURE 34. A photograph of the interior of the housing for the subject Circuit Breaker from the subject Meter/Breaker Panel. (Image No.: NEC\_4047)

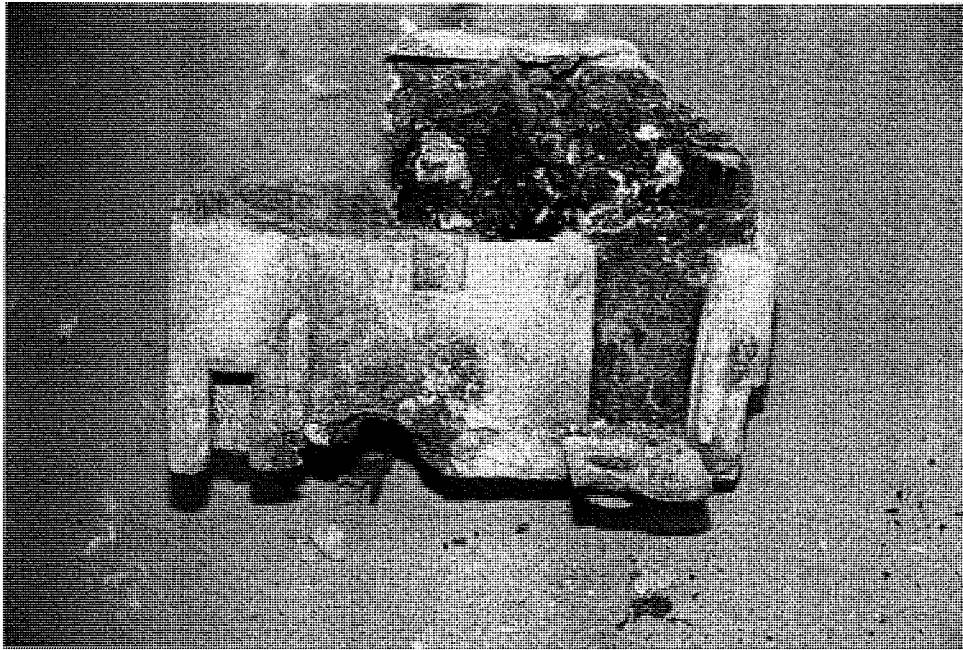
FIGURE 35. A photograph of the Load Side for the subject Circuit Breaker from the subject Meter/Breaker Panel. (Image No.: NEC\_4049)

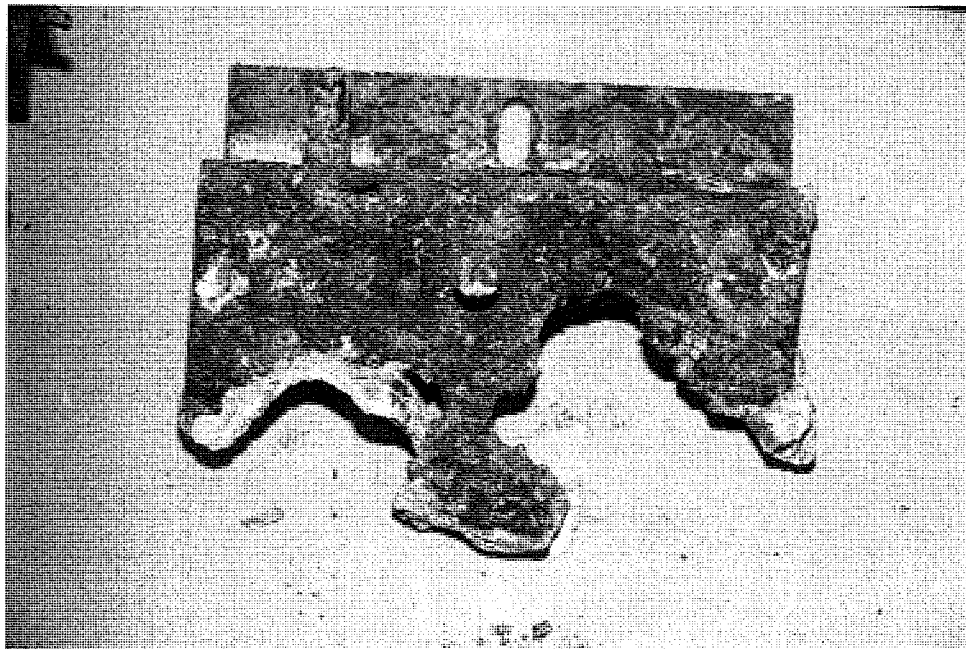
FIGURE 36. A photograph of the top side for the lower portion of the subject Mounting Base for the subject Circuit Breaker from the Housing for the subject Meter/Breaker Panel. (Image No.: NEC\_3874)

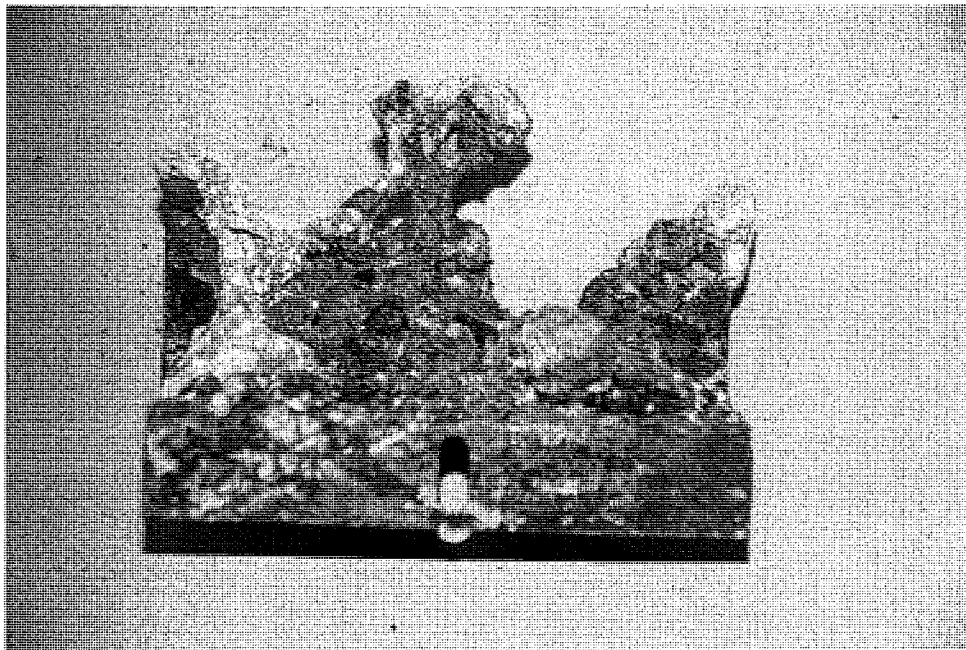
FIGURE 37. A photograph of the underside for the lower portion of the subject Mounting Base for the subject Circuit Breaker from the Housing for the subject Meter/Breaker Panel. (Image No.: NEC\_3925)
