UNITED STATES DISTRICT COURT  
DISTRICT OF CONNECTICUT

Case No. 3:11-cv-1741 (CSH)

**RULINGS ON DEFENDANT'S MOTIONS TO PRECLUDE EXPERT  
WITNESS TESTIMONY AND FOR SUMMARY JUDGMENT**

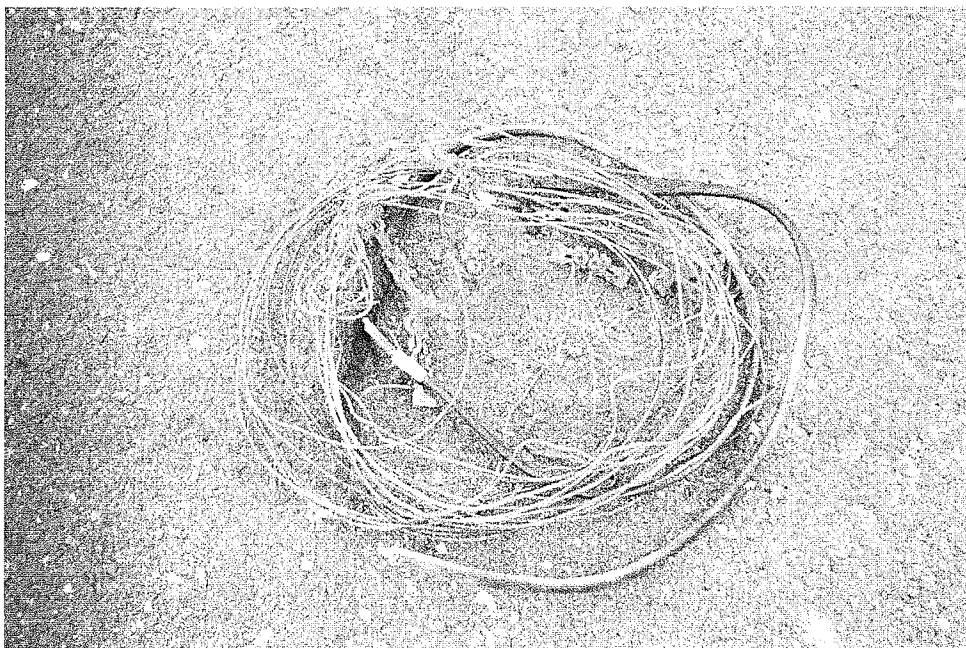
FIGURE 38. A photograph of the Branch Circuit Conductors and Duplex Receptacles from the Omega House. (Image No.: NEC\_1555)

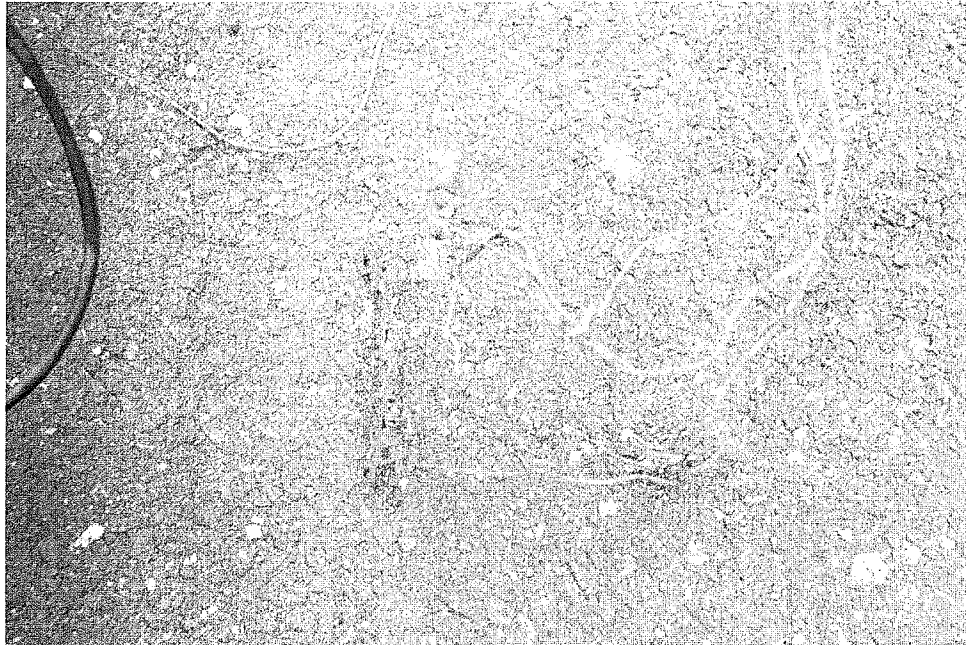
FIGURE 39. A photograph of one of the Duplex Receptacles for the Branch Circuit Conductors from the Omega House. (Image No.: NEC\_1564)

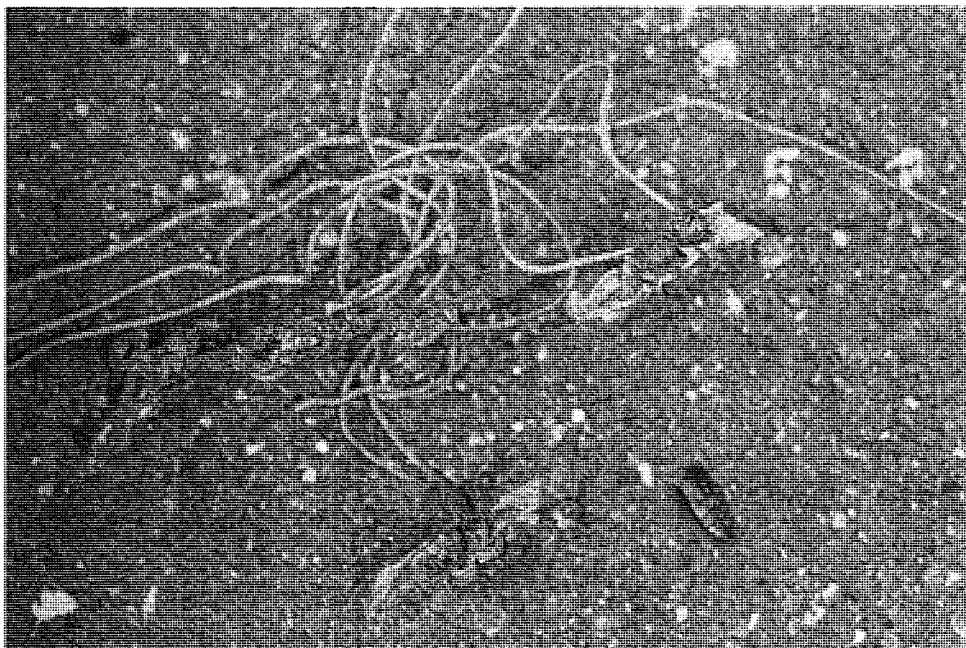
FIGURE 40. A photograph of the second Duplex Receptacle for the Branch Circuit Conductors from the Omega House. (Image No.: NEC\_1599)

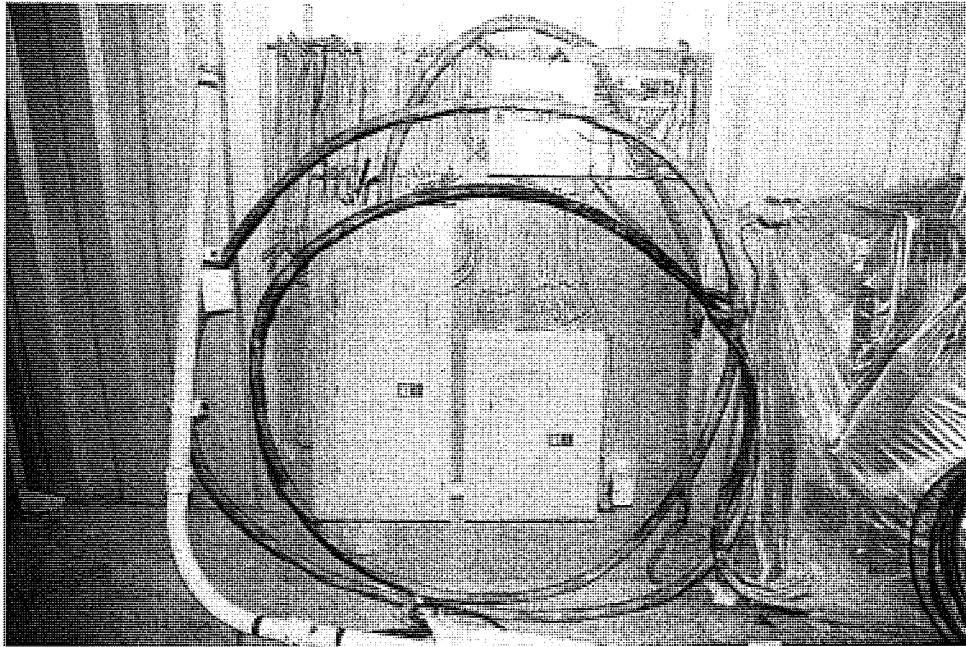
FIGURE 41. A photograph of the Electrical Distribution Panel, Subpanel, Alarm Monitoring Panel, and subject Distribution Cable from the Omega House. (Image No.: NEC\_1615)

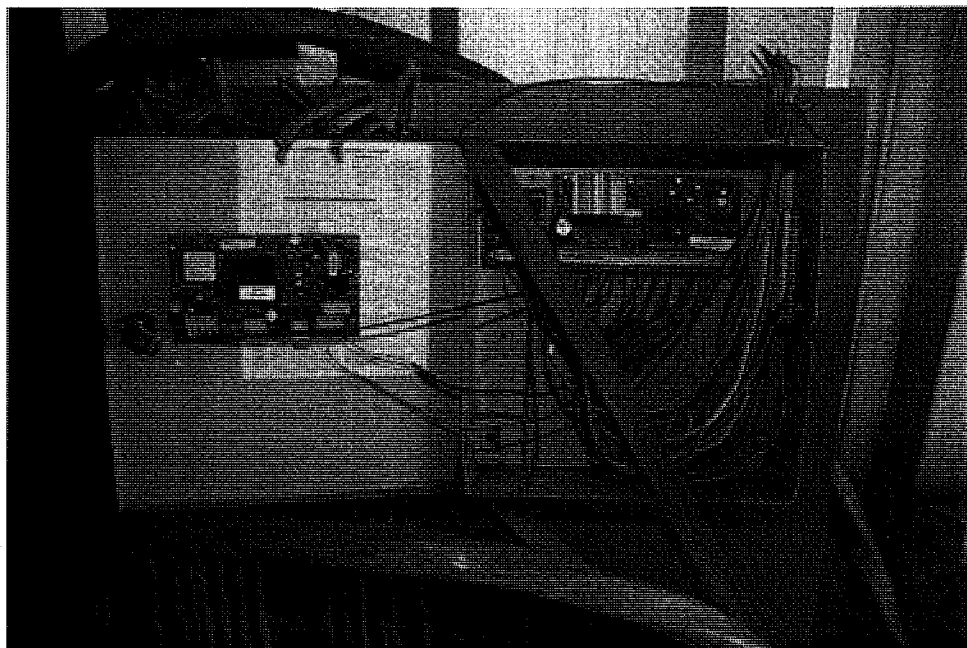
FIGURE 42. A photograph of the Alarm Monitoring Panel from the Omega House. (Image No.: NEC\_1629)

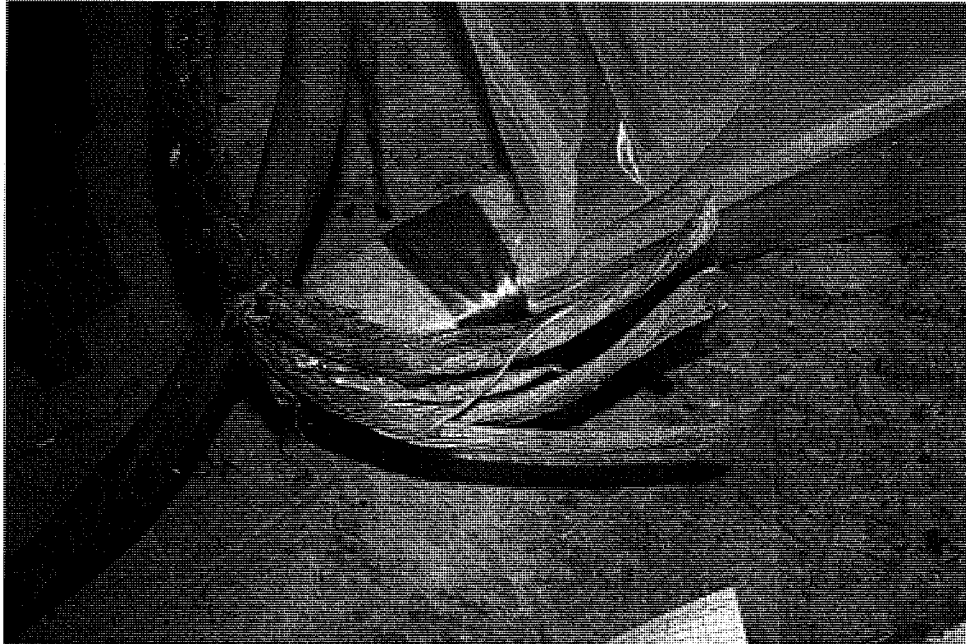
FIGURE 43. A photograph of the subject Distribution Cable from the subject Meter/Breaker Panel. (Image No.: NEC\_1688)

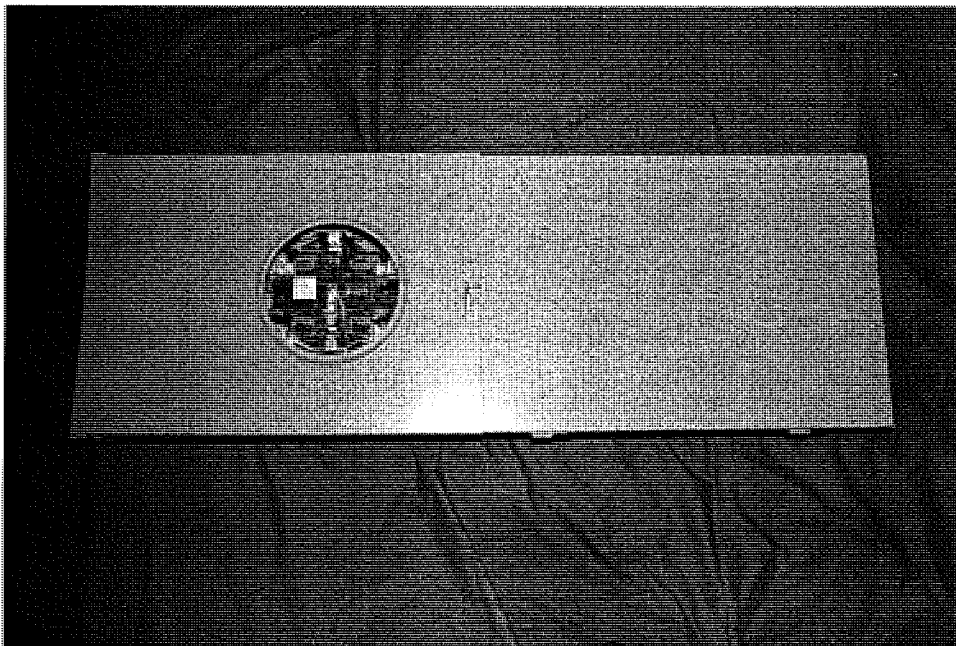
FIGURE 44. A photograph of the exemplar Meter/Breaker Panel. (Image No.: NEC\_1694)

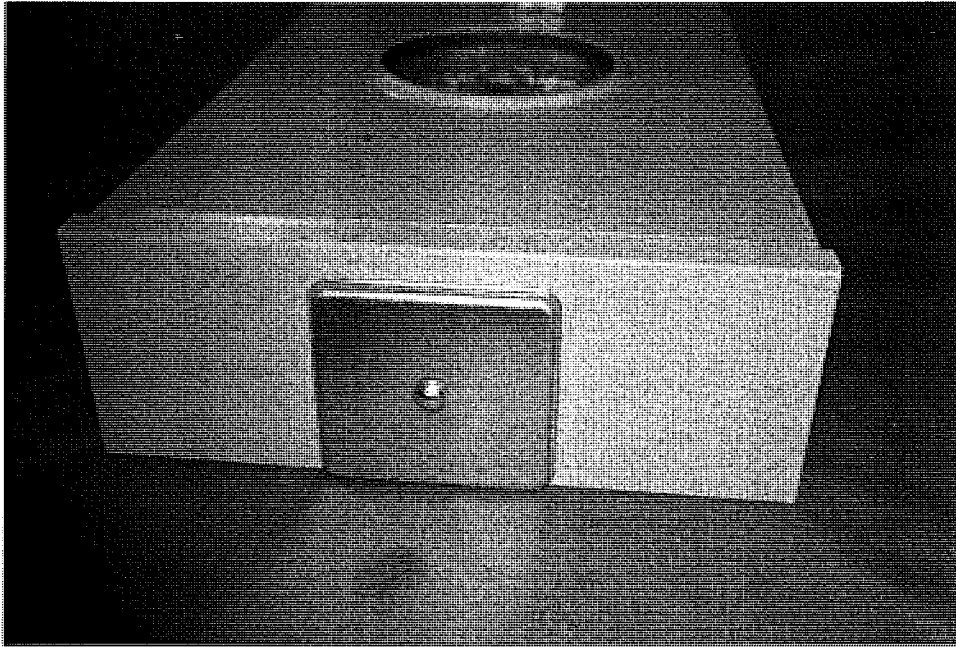
FIGURE 45. A photograph of the Top End Wall of the exemplar Meter/Breaker Panel. (Image No.: NEC\_1696)

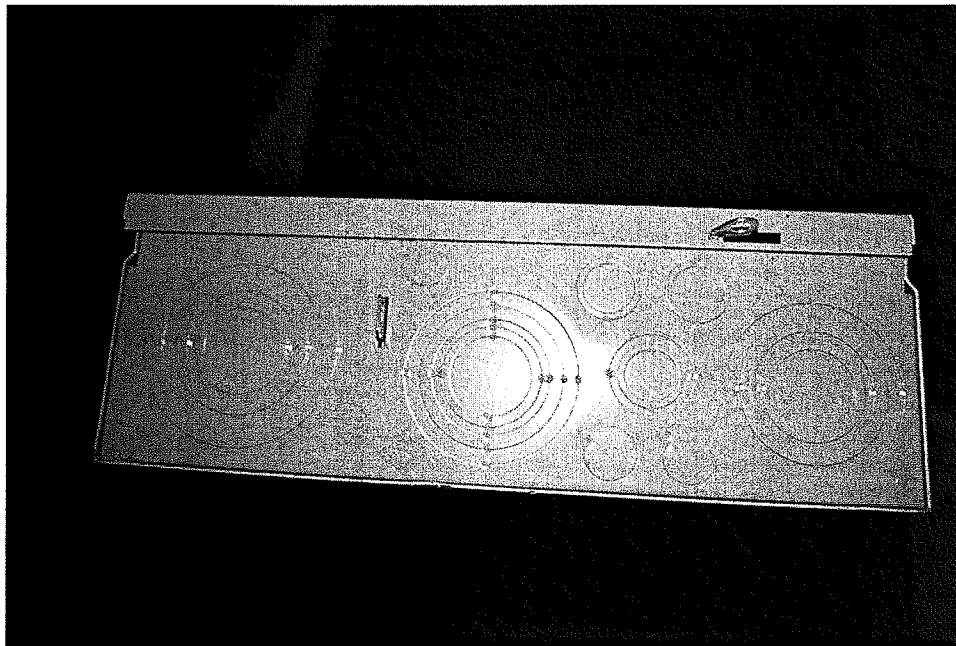
FIGURE 46. A photograph of the Bottom End Wall of the exemplar Meter/Breaker Panel. (Image No.: NEC\_1698)

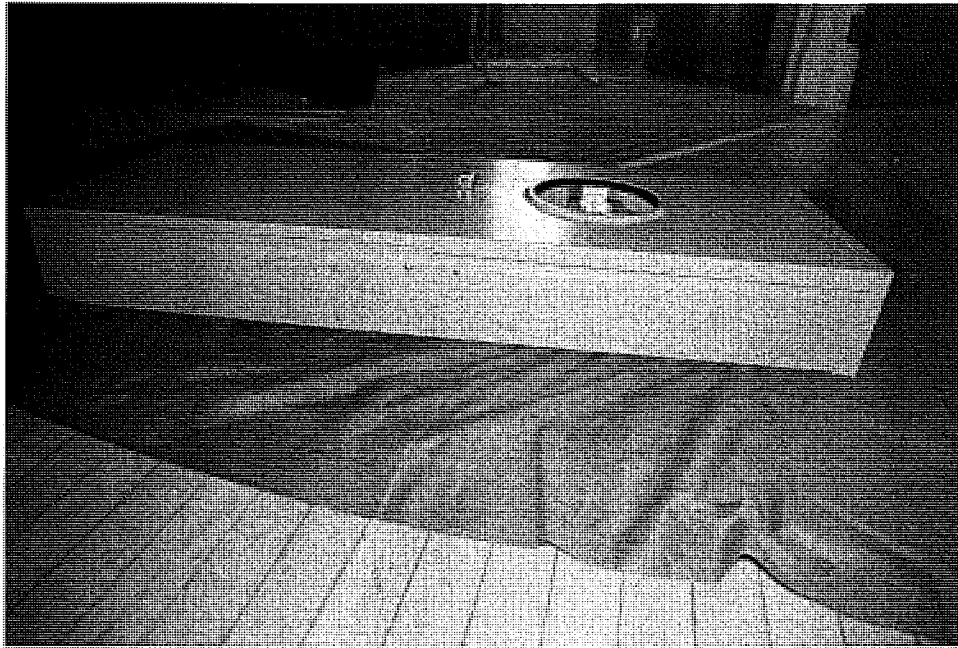
FIGURE 47. A photograph of the Right Side of the exemplar Meter/Breaker Panel. (Image No.: NEC\_1701)

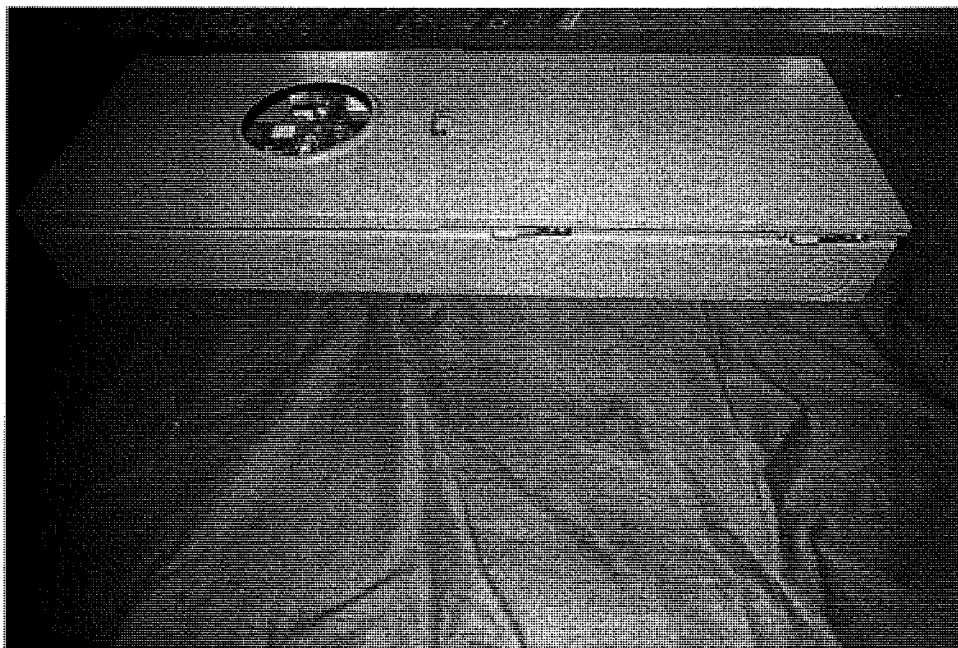
FIGURE 48. A photograph of the Left Side of the exemplar Meter/Breaker Panel. (Image No.: NEC\_1697)

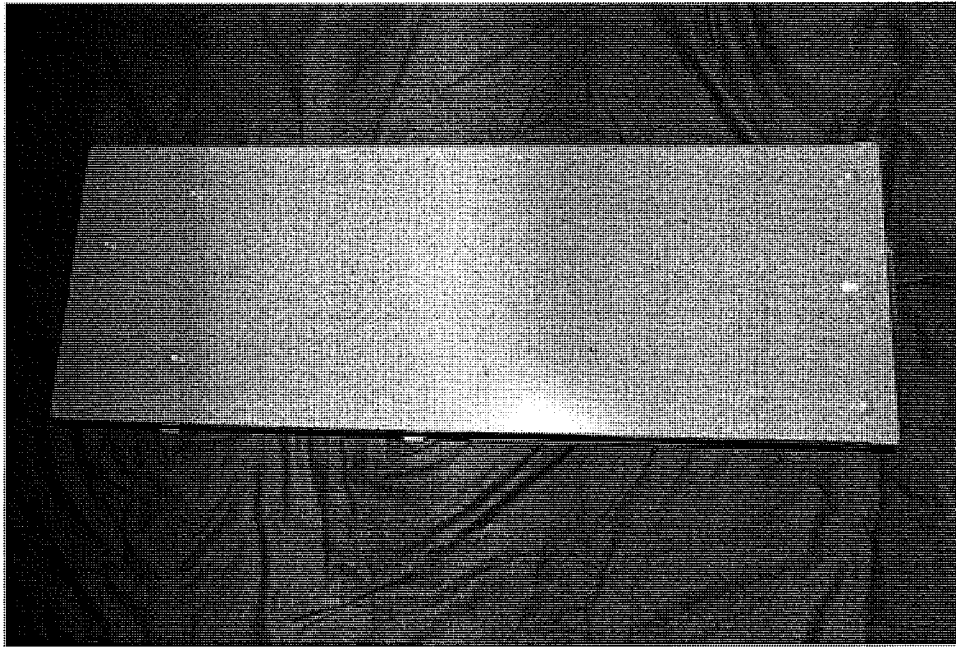
FIGURE 49. A photograph of the Rear of the Housing for the exemplar Meter/Breaker Panel.  
(Image No.: NEC\_1704)

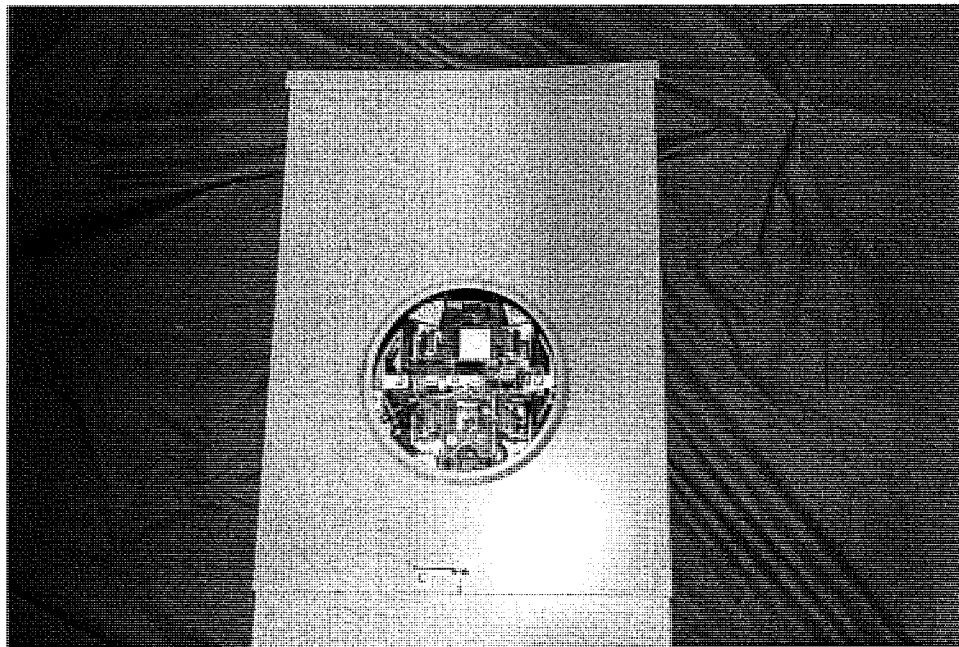
FIGURE 50. A photograph of the Meter Compartment for the exemplar Meter/Breaker Panel.  
(Image No.: NEC\_1705)

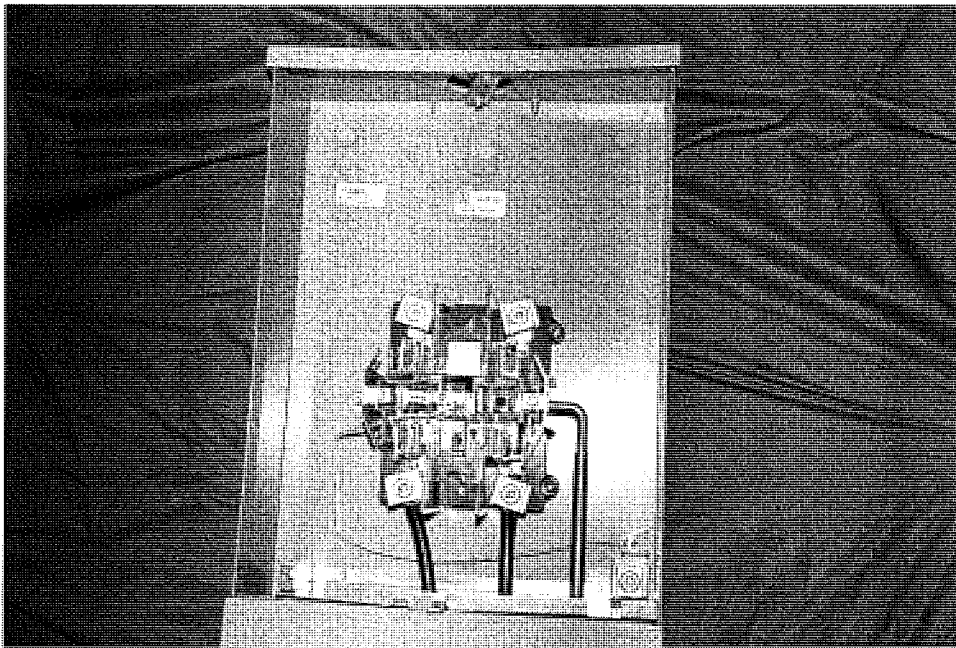
FIGURE 51. A photograph of the interior enclosure for the Meter Compartment for the exemplar Meter/Breaker Panel. (Image No.: NEC\_1708)

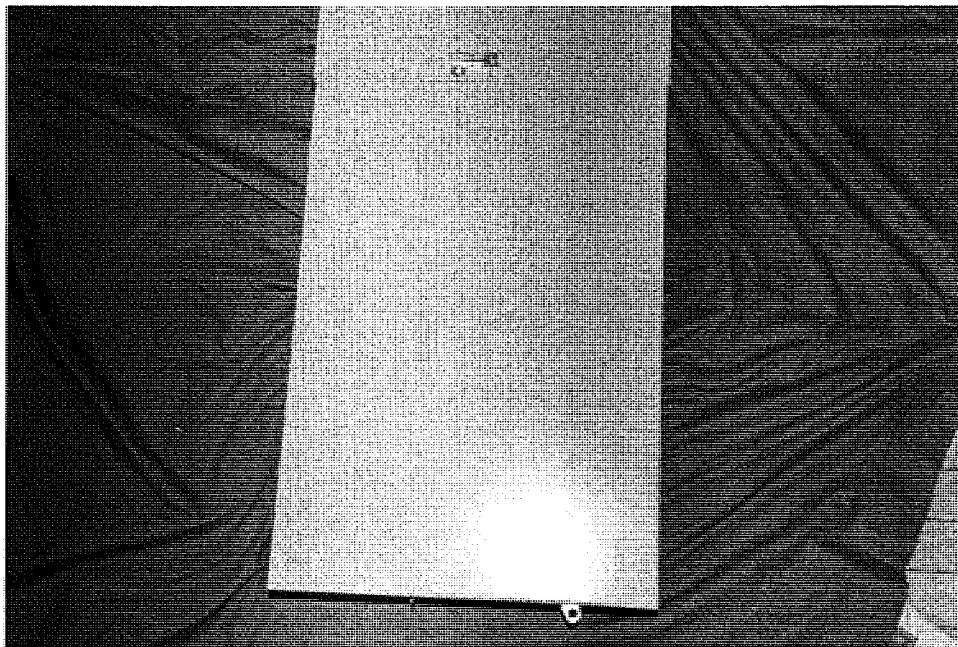
FIGURE 52. A photograph of the Breaker Compartment for the exemplar Meter/Breaker Panel. (Image No.: NEC\_1707)

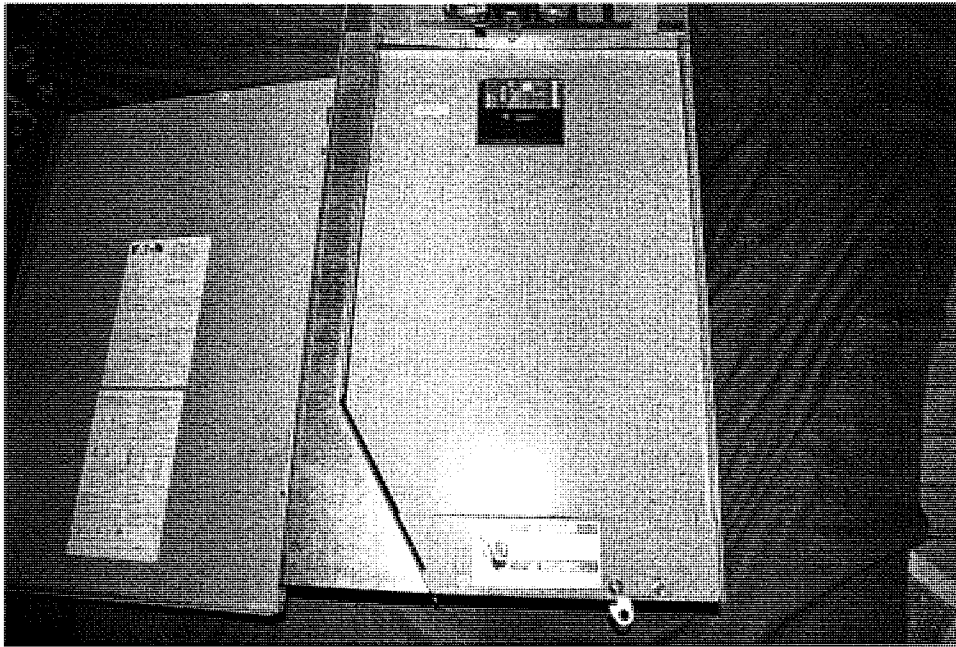
FIGURE 53. A photograph of the Breaker Compartment for the exemplar Meter/Breaker Panel with the Deadfront Cover in place. (Image No.: NEC\_1709)

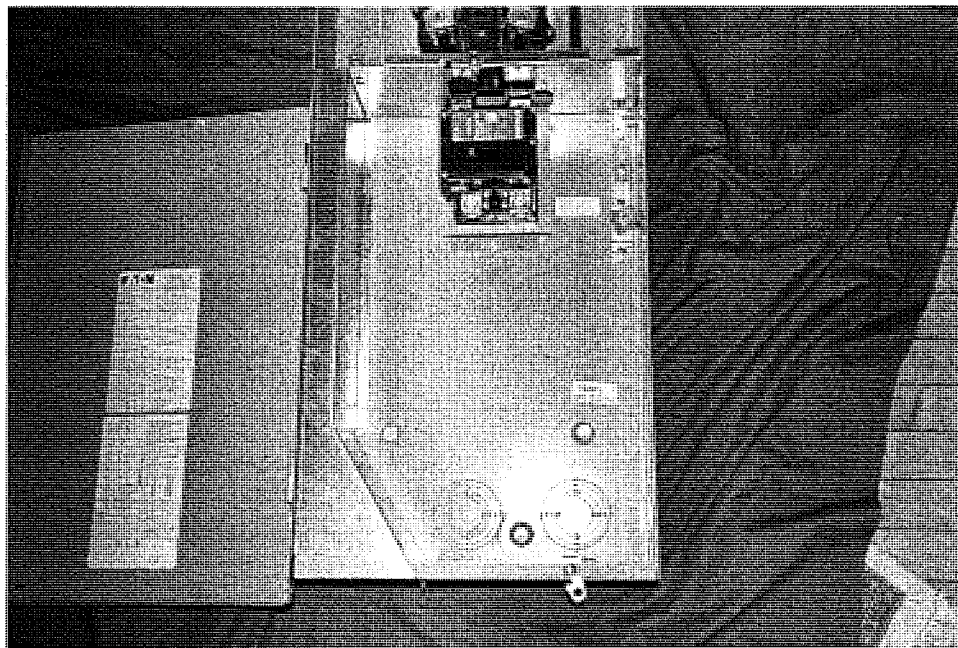
FIGURE 54. A photograph of the interior enclosure of the Breaker Compartment for the exemplar Meter/Breaker Panel with the exemplar Deadfront Cover removed. (Image No.: NEC\_1712)

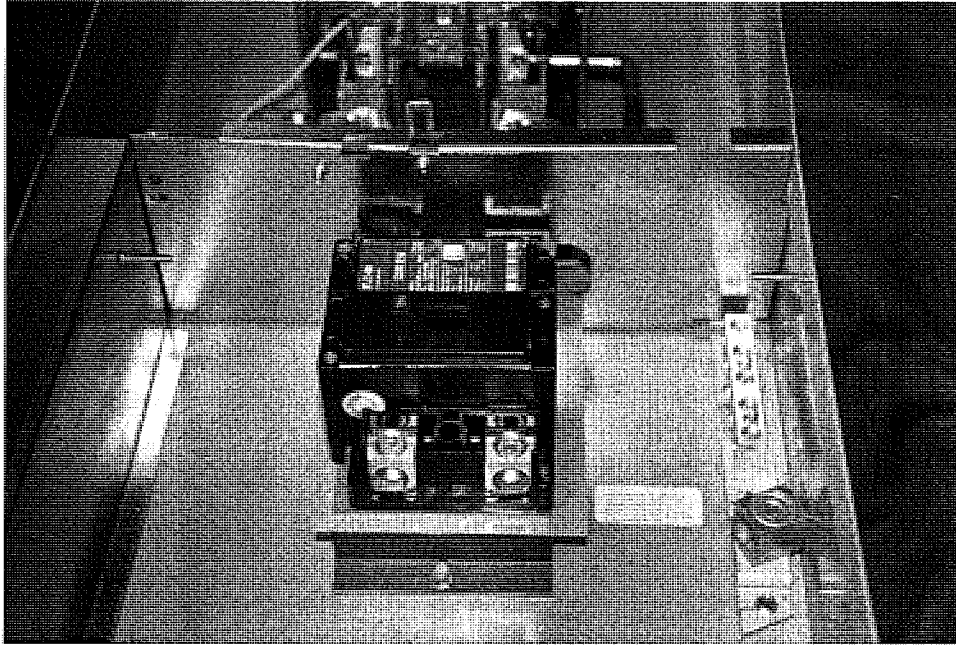
FIGURE 55. Photograph of the exemplar Barrier between the Meter Compartment and the Breaker Compartment for the exemplar Meter/Breaker Panel. (Image No.: NEC\_1715)

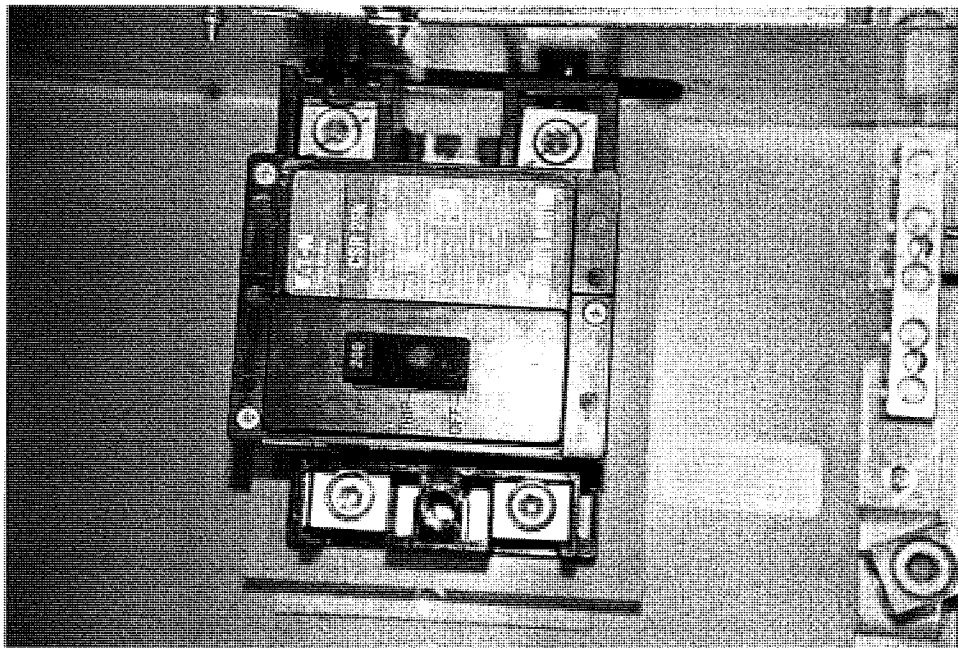
FIGURE 56. Photograph of the exemplar Circuit Breaker in the exemplar Meter/Breaker Panel. (Image No.: NEC\_1723)

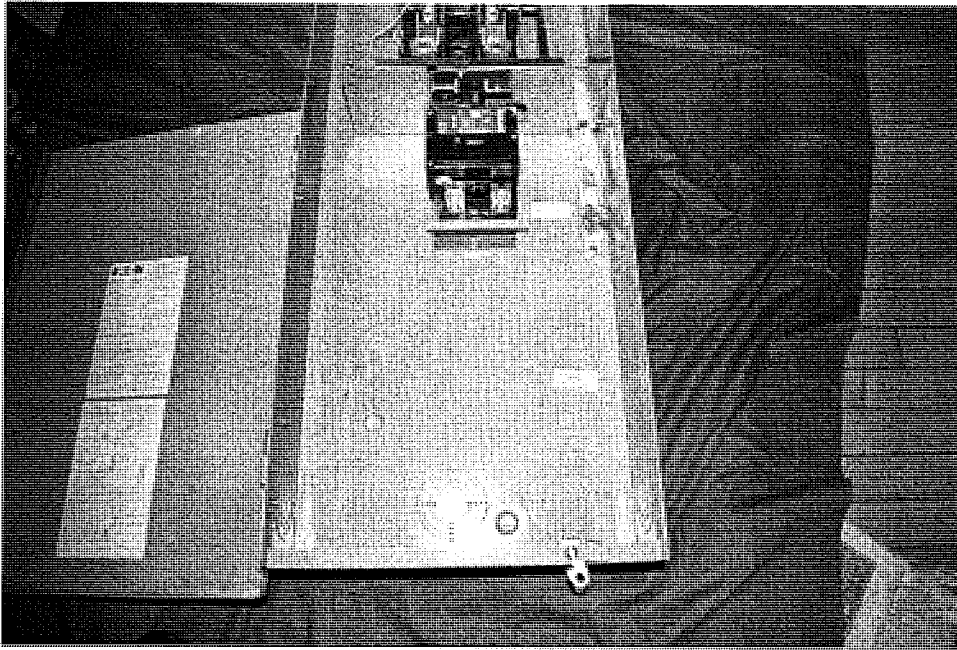
FIGURE 57. Photograph of the interior enclosure of the Breaker Compartment for the exemplar Meter/Breaker Panel with the exemplar Wiring Gutter Enclosure removed. (Image No.: NEC\_1717)

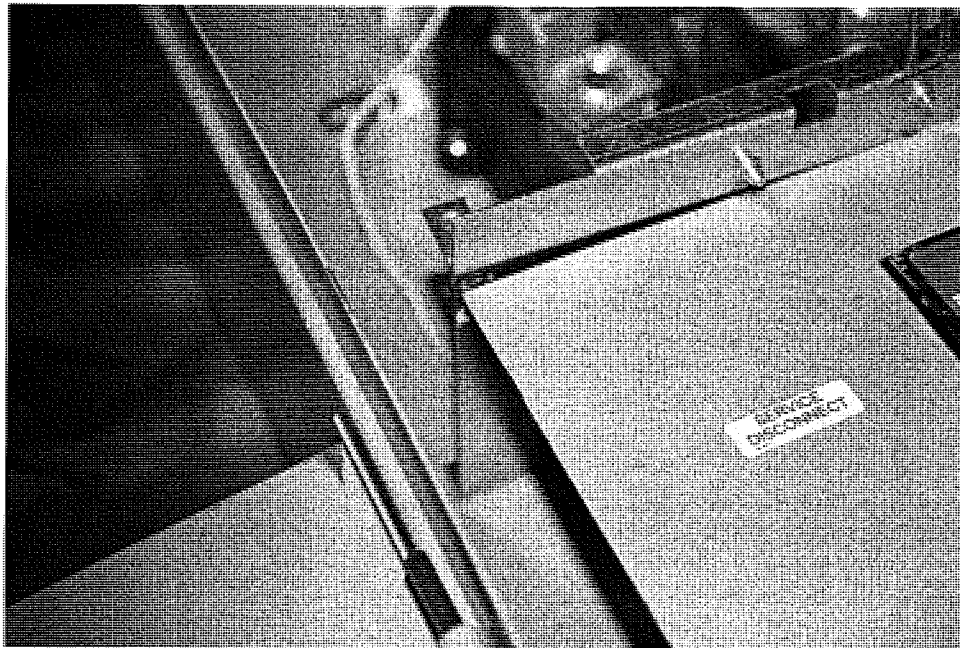
FIGURE 58. Photograph of the interior view of the Breaker Compartment for the exemplar Meter/Breaker Panel with the exemplar Wiring Gutter Enclosure removed and showing the edges of the exemplar Barrier and the exemplar Deadfront Cover. (Image No.: NEC\_1727)

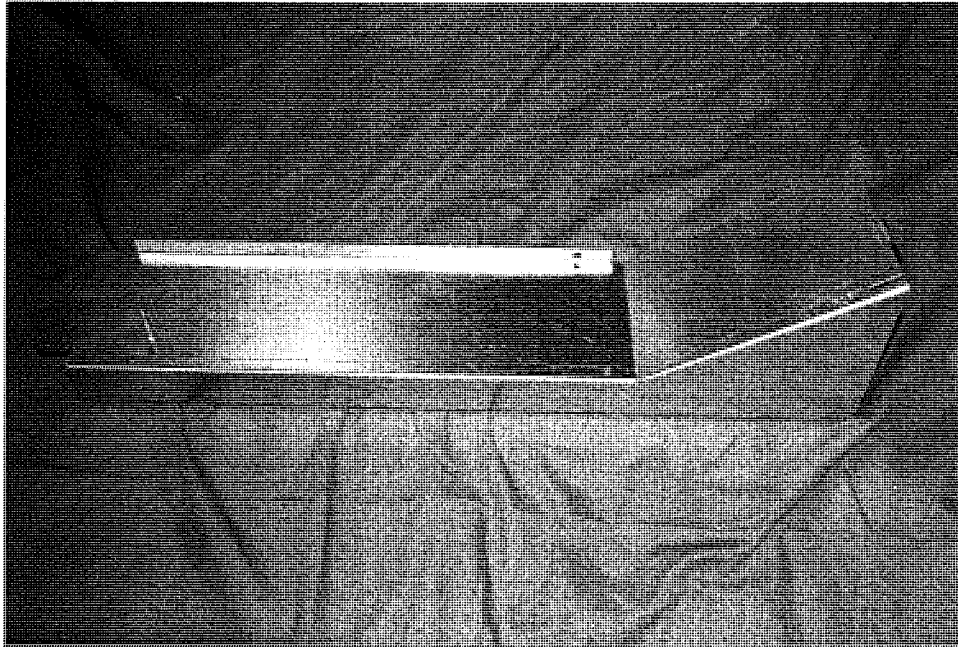
FIGURE 59. Photograph of the exemplar Wiring Gutter Enclosure from the exemplar Meter/Breaker Panel. (Image No.: NEC\_1729)

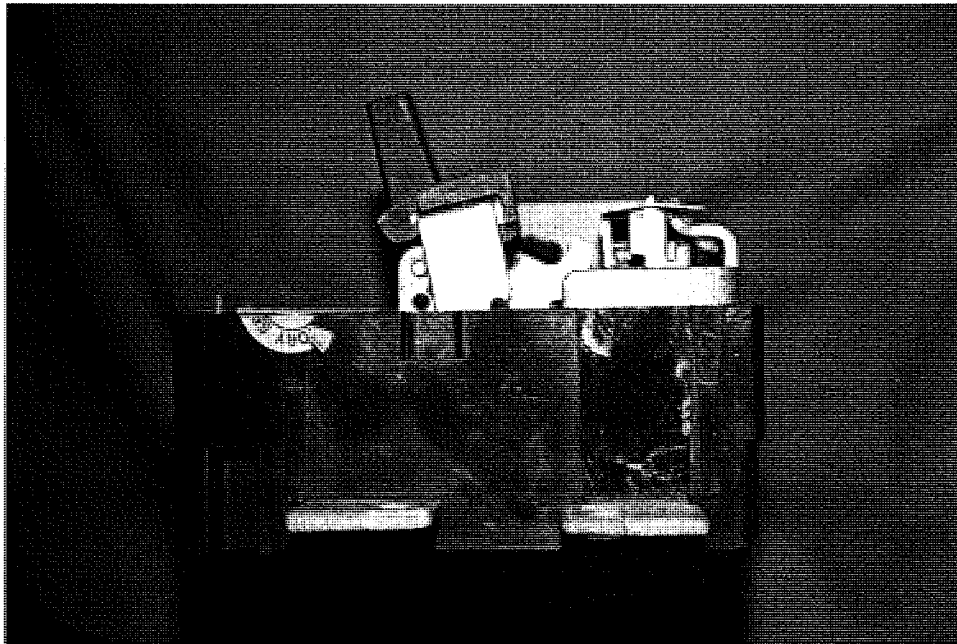
FIGURE 60. Photograph of the interior components of the exemplar Circuit Breaker with the Handle in the ON Condition. (Image No.: NEC\_1737)

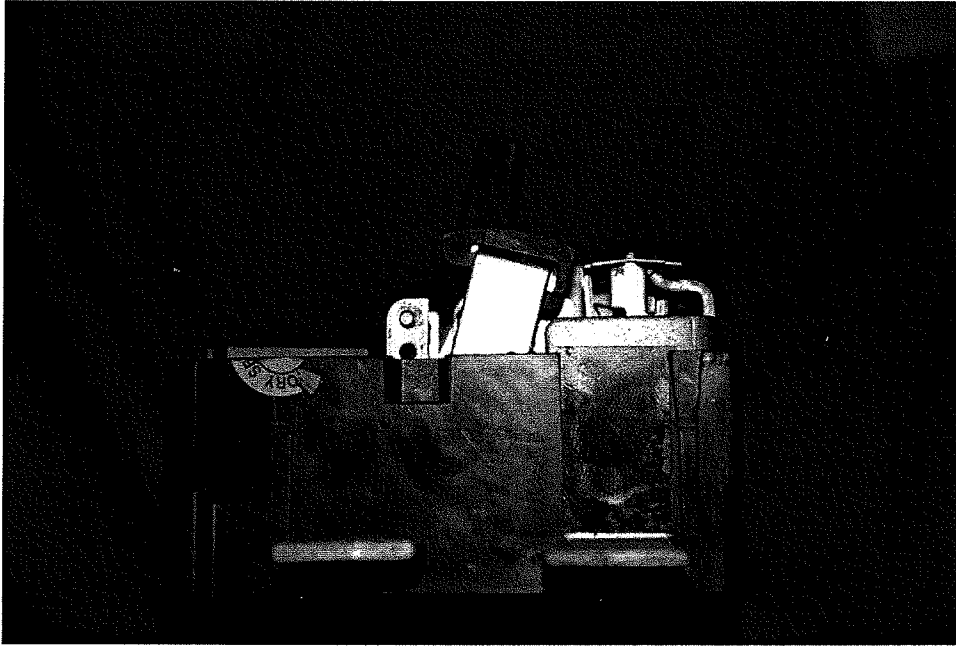
FIGURE 61. Photograph of the interior components of the exemplar Circuit Breaker with the Handle in the OFF Condition. (Image No.: NEC\_1738)
