**IN THE UNITED STATES DISTRICT COURT
FOR THE SOUTHERN DISTRICT OF ALABAMA
SOUTHERN DIVISION**

ATLANTIC SPECIALTY INSURANCE COMPANY,)	
)	
)	
Plaintiff,)	
)	
vs.)	CIVIL ACTION NO. 13-458-CG-N
)	
MR. CHARLIE ADVENTURES,)	
LLC and KIM P. KORNEGAY,)	
)	
Defendant.)

ORDER

*Survey Report No: 13-IMU-0176**Report Date: September 9, 2013**Atlantic, Gulf & Pacific
Marine Surveyors and Consultants, Inc.***MARCH 8, 2013 ATTENDANCE:**

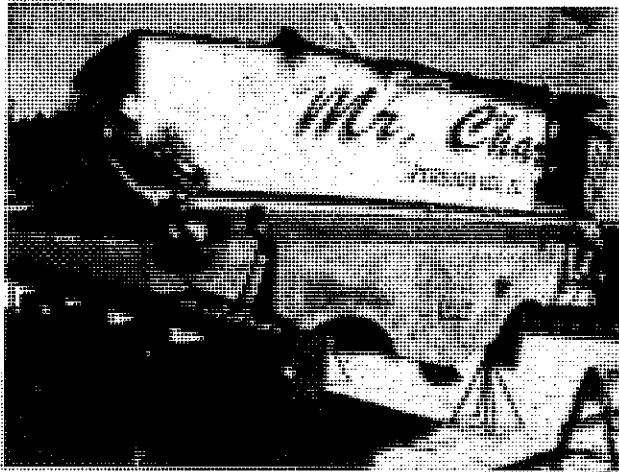
(Stbd Main Engine Below)

Starboard main engine suffered the most extensive heat/fire damage of the two main engines with aluminum the cooling water expansion tank completely melted, thermostat housing completely melted, inner cooler forward housing completely melted, forward end of the oil cooler housing melted.

Starboard main engine turbo charger appears to be a potential area of origin on the inlet side which was completely destroyed and no fragments found. The fuel service centre near the turbo was significantly melted and Racor dual filter housing located just inboard was completely destroyed with minor fragments found.

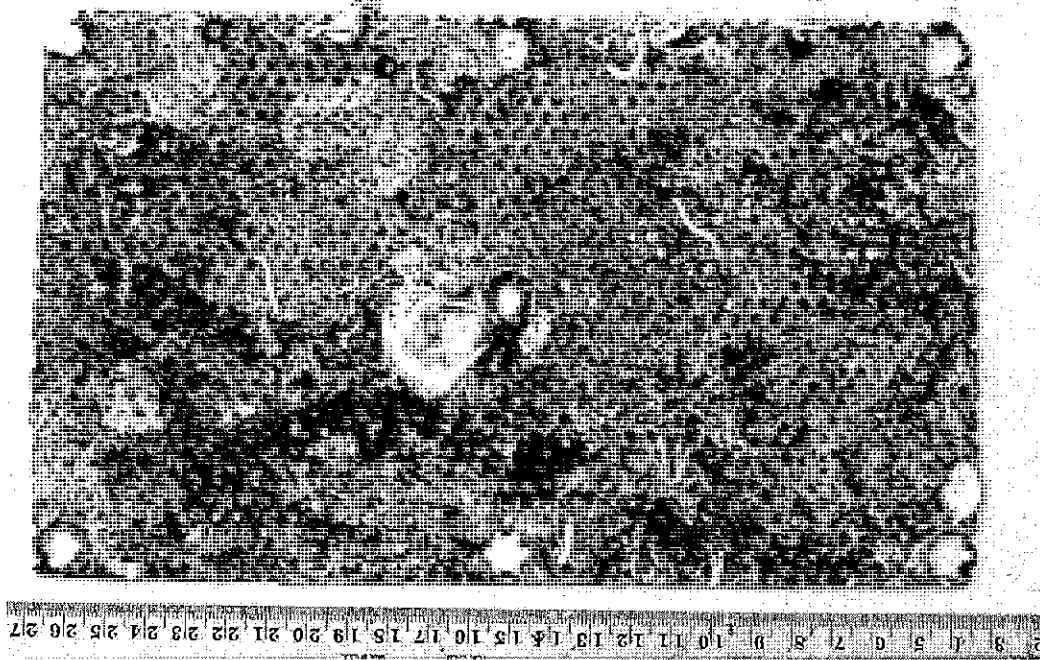
The starboard and port sea water intake screens are shown as received in Figures 1-4. Considerable marine fouling including oyster shells was observed on both screens. Each screen was photographed digitally with back lighting and photographically enhanced to increase contrast between open holes and screen material. The images were then analyzed in an image analysis system (Able Image Analyser) to calculate the percentage open area. A new, unused screen was used as a base line. The basic input images are shown in Figures 5 and 6. A steel scale used to calibrate image size can just be seen in Figure 6.

Figure 1: The outboard surface of the port screen is shown as received. An oyster shell is growing in the center.

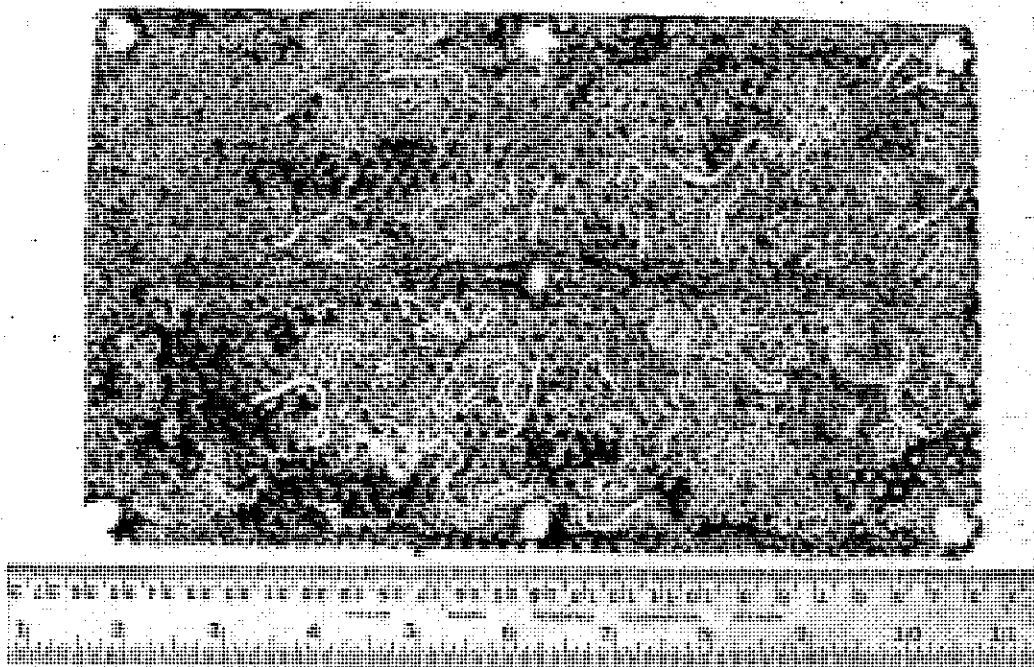
Figure 2: The port inboard side is shown.

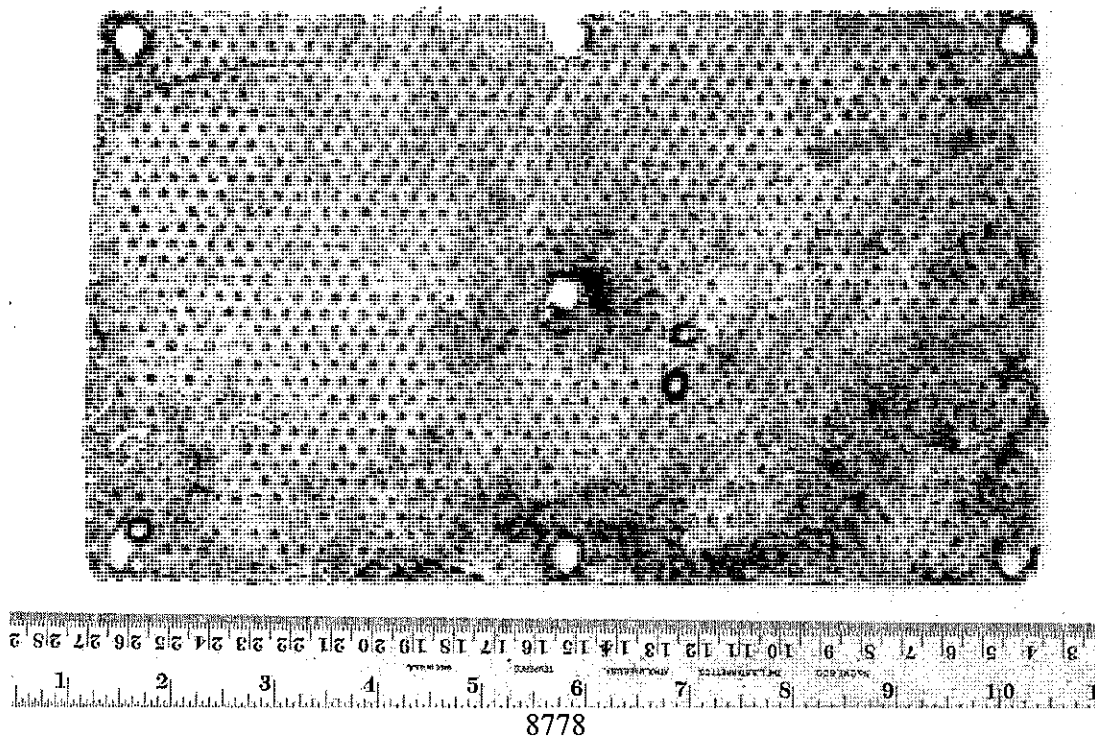
Figure 3: The starboard outboard surface of the sea water intake screen is shown as received.

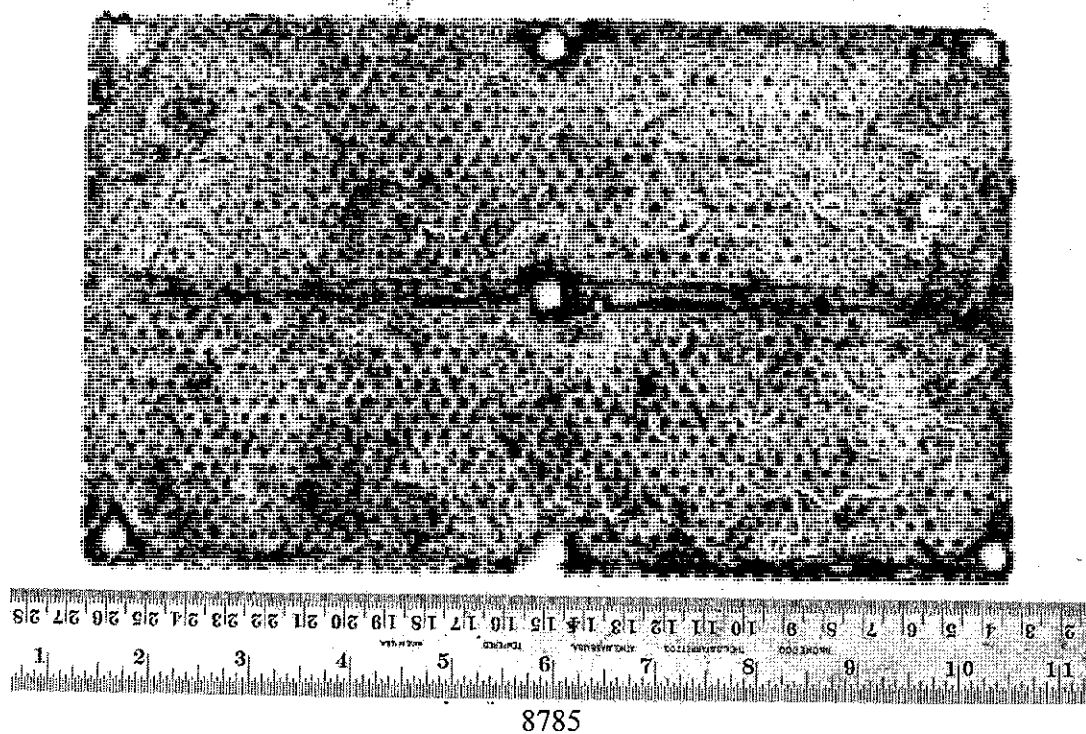
Figure 4: The starboard inboard side is shown.

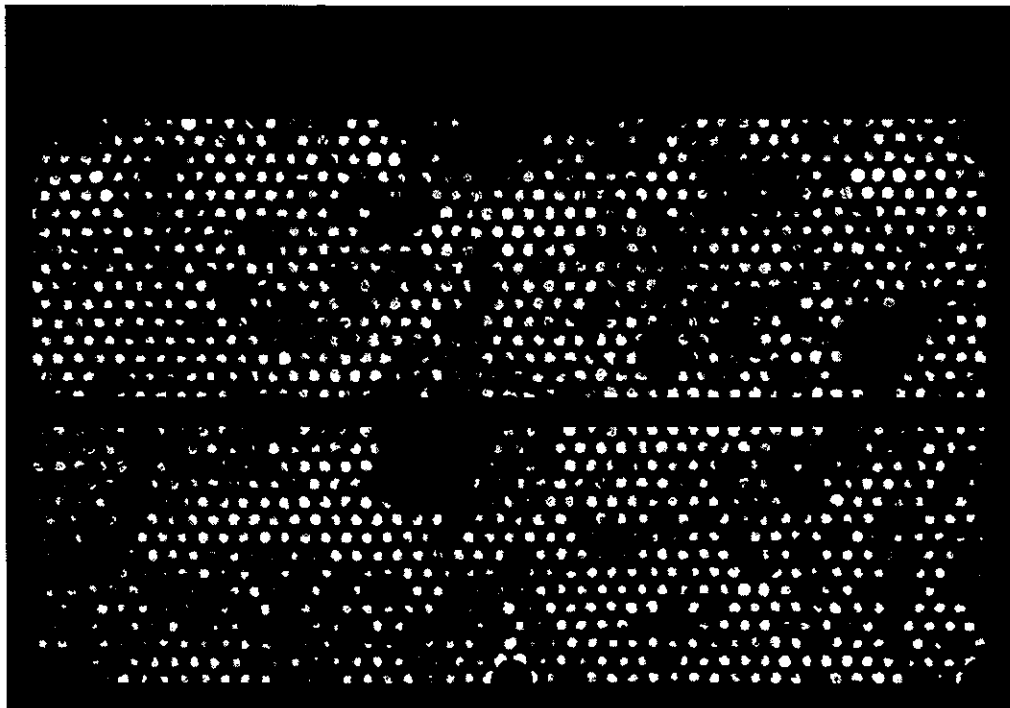
port side screen

It was determined by the undersigned that there were three (3) holes on the starboard screen which were 100% open and two (2) holes on the port screen 100% open. The sea scoops were indentified as Groco part # APHS-3000-2 bronze sea strainers. The screens were found to be manufactured by Hendrick Corporation having a Groco part #93-3000-2, stainless steel, having .125 diameter perforated holes. Both screens were found to be significantly fouled with marine growth and paint.

Figure 5: Port screen photo was shot with high contrast for image analysis.

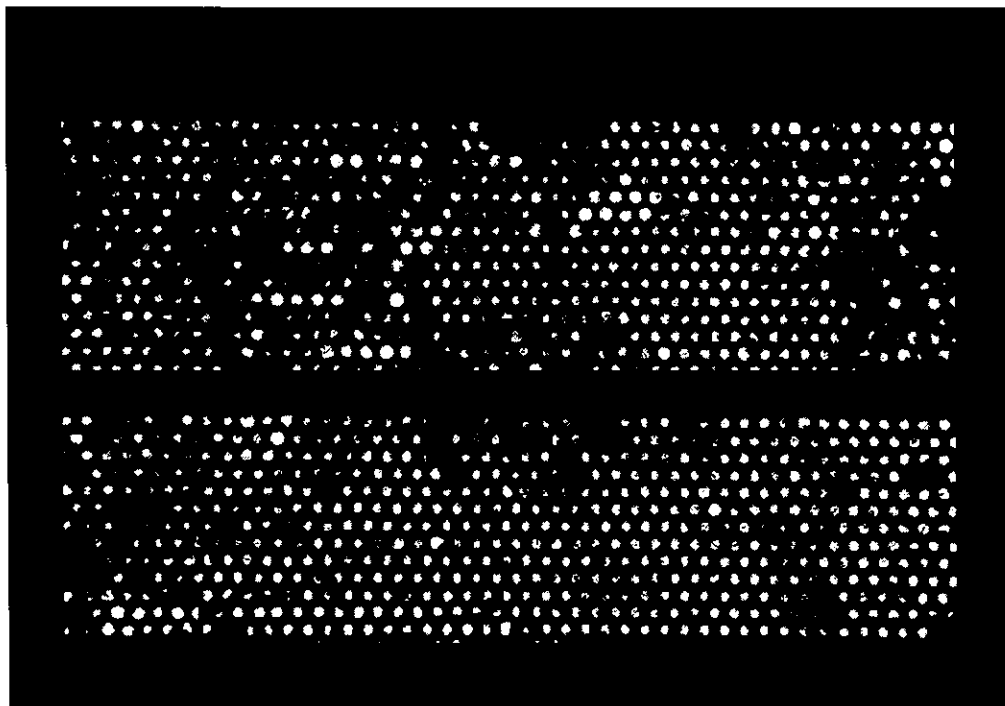
Figure 6: The starboard side screen was shot with high contrast for image analysis.

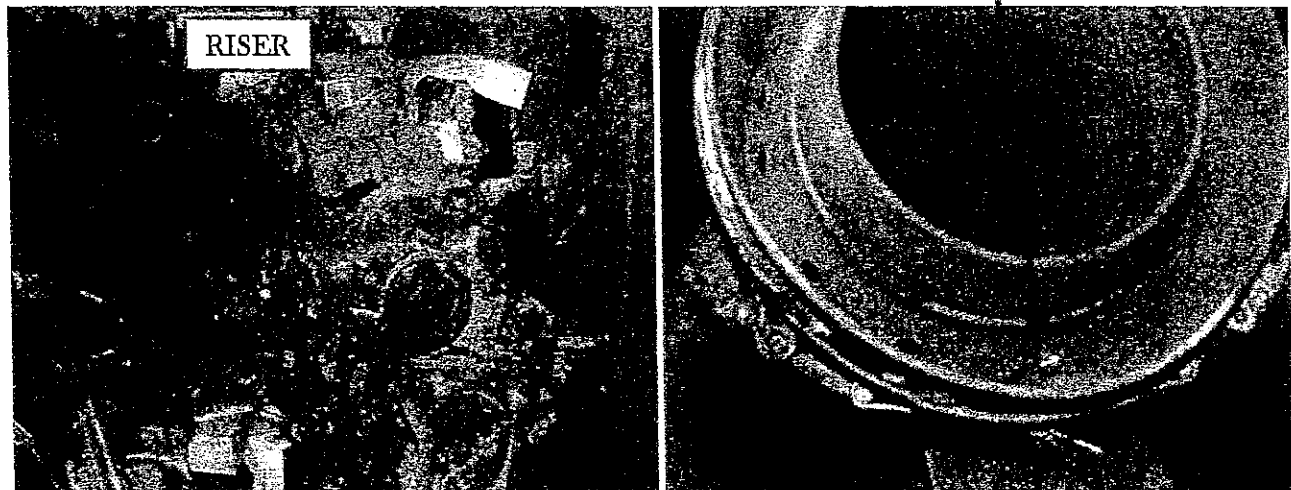
At the time of the starboard engine inspection at Middleton Marine shop located in Orange Beach, AL, the exhaust riser remained attached with both openings exposed at each end of the riser pipe once the turbocharger was removed. It was noted that one of the "showerhead" holes located at the bottom center of the ring, was plugged up with hard deposits.

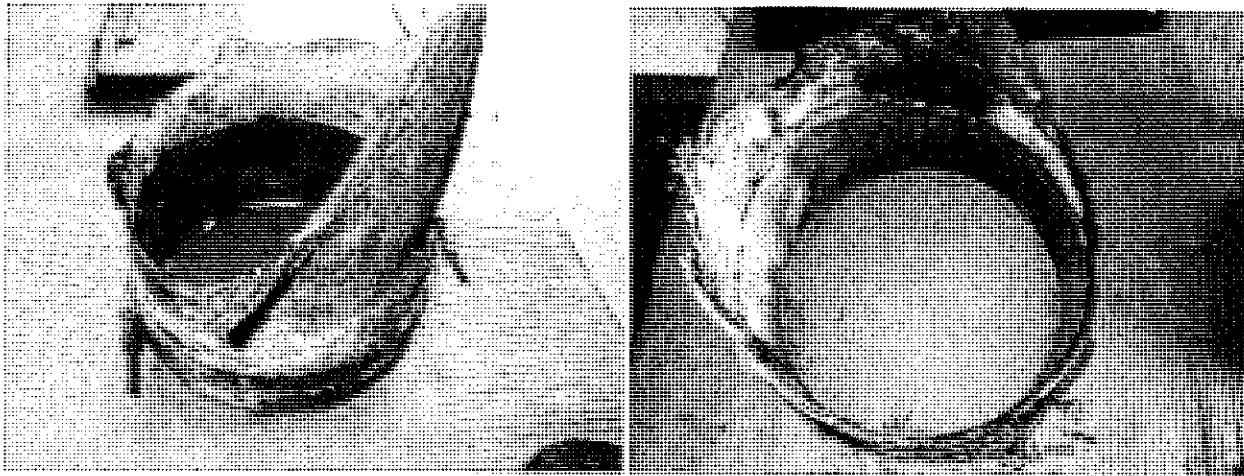
The port and starboard FRP exhaust tubes were recovered from the fire debris by the undersigned and were retained as evidence. The port FRP exhaust tube was found completely intact with some negligible burning exhibited on the outer fiberglass which is associated with the resulting surrounding fire (flames). The starboard FRP exhaust tube was found almost completely destroyed with evidence it remaining which consisted of the opposing ends of the tube (the inlet and outlet connections) for the exhaust. There was extreme consumption of the fiberglass tube, evidence a catastrophic failure of the starboard exhaust tube as a result of localized intense heat and burning (flames), and tube appeared burnt from the inside out. (Refer to AGP exhaust tube photos)

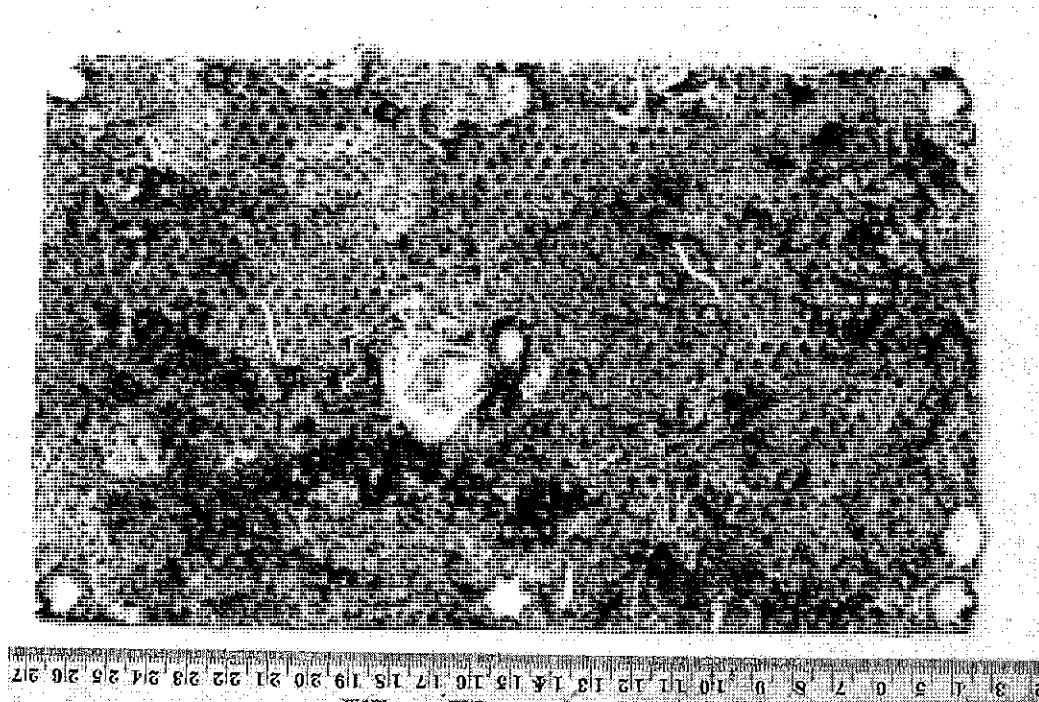
The starboard and port sea water intake screens are shown as received in Figures 1-4. Considerable marine fouling including oyster shells was observed on both screens. Each screen was photographed digitally with back lighting and photographically enhanced to increase contrast between open holes and screen material. The images were analyzed in an image analysis system (Able Image Analyser) to calculate the percentage open area. A new, unused screen was used as a base line. The basic input images are shown in Figures 5 and 6. A steel scale used to calibrate image size can just be seen in Figure 6.

Figure 1: The outboard surface of the port screen is shown as received. An oyster shell is growing in the center.

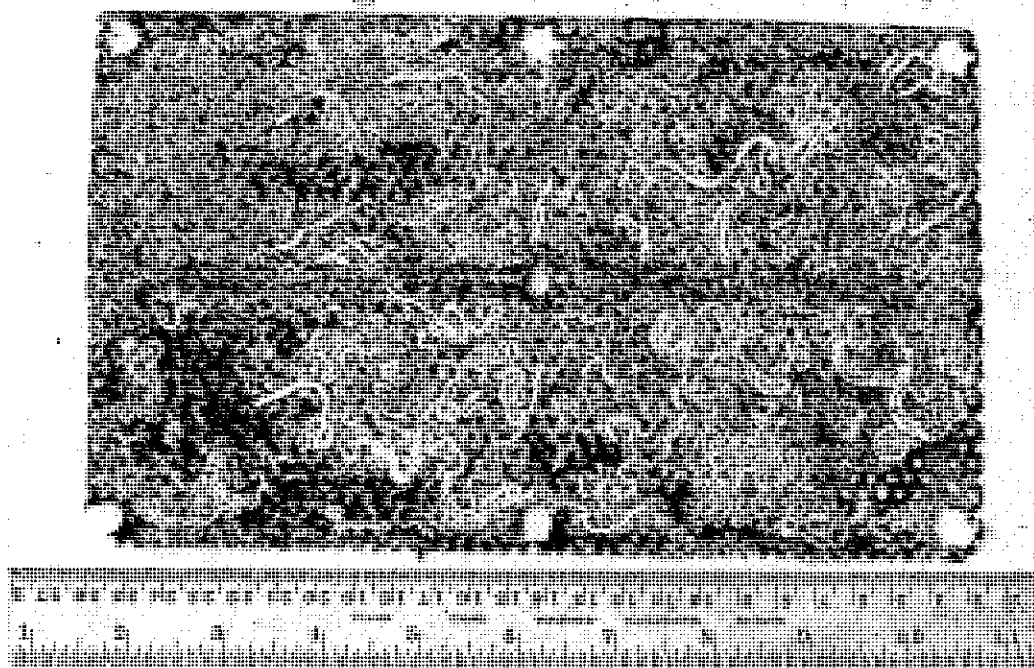
Figure 2: The port inboard side is shown.

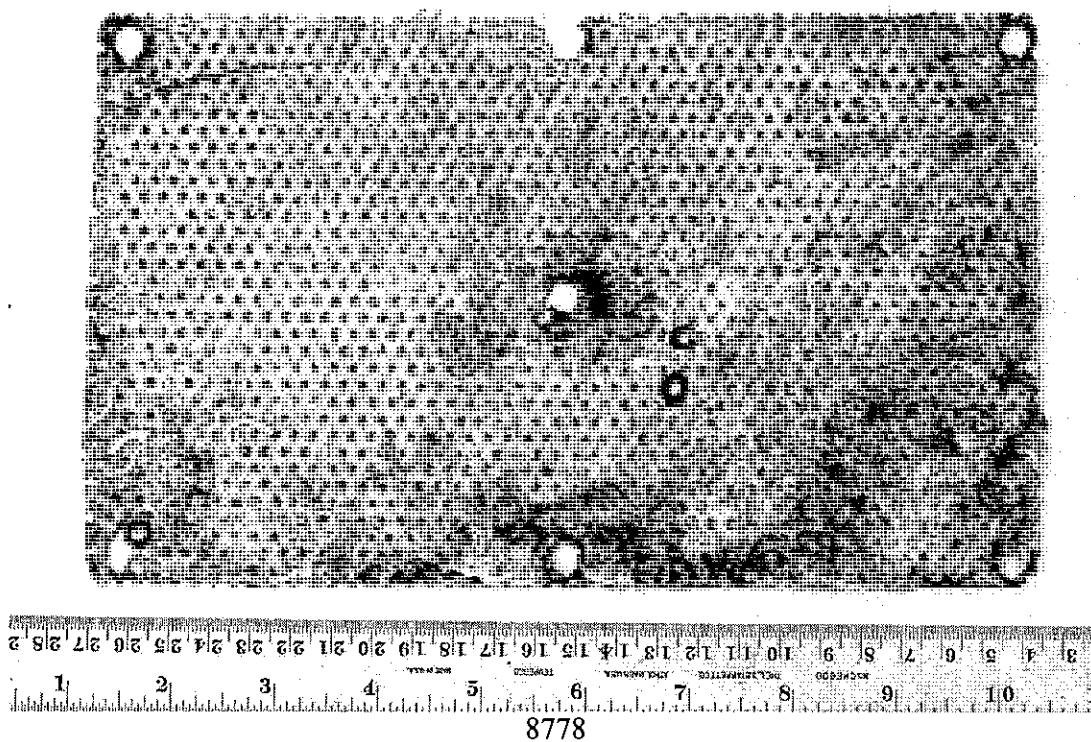
Figure 3: The starboard outboard surface of the sea water intake screen is shown as received.

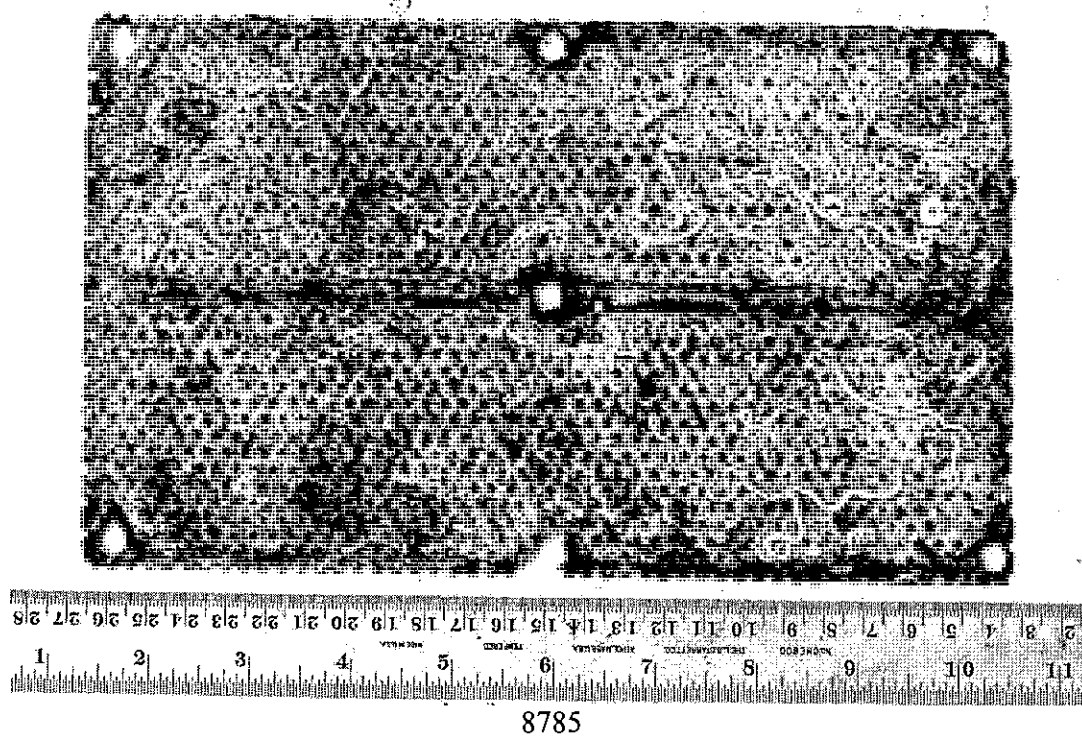
Figure 4: The starboard inboard side is shown.

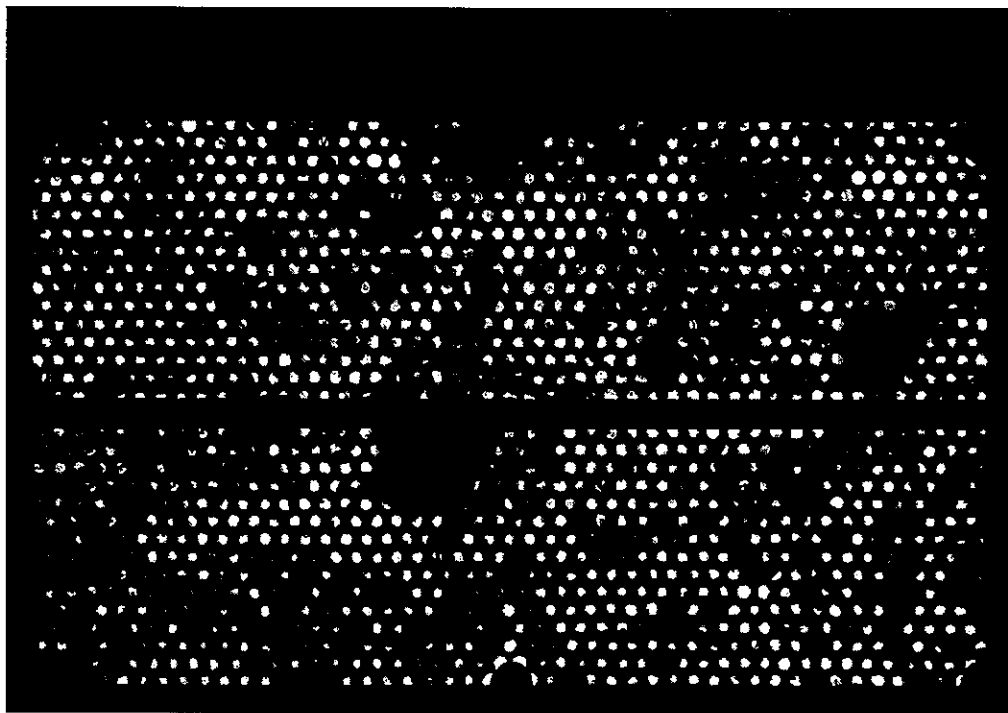
port side screen

Figure 5: Port screen photo was shot with high contrast for image analysis.

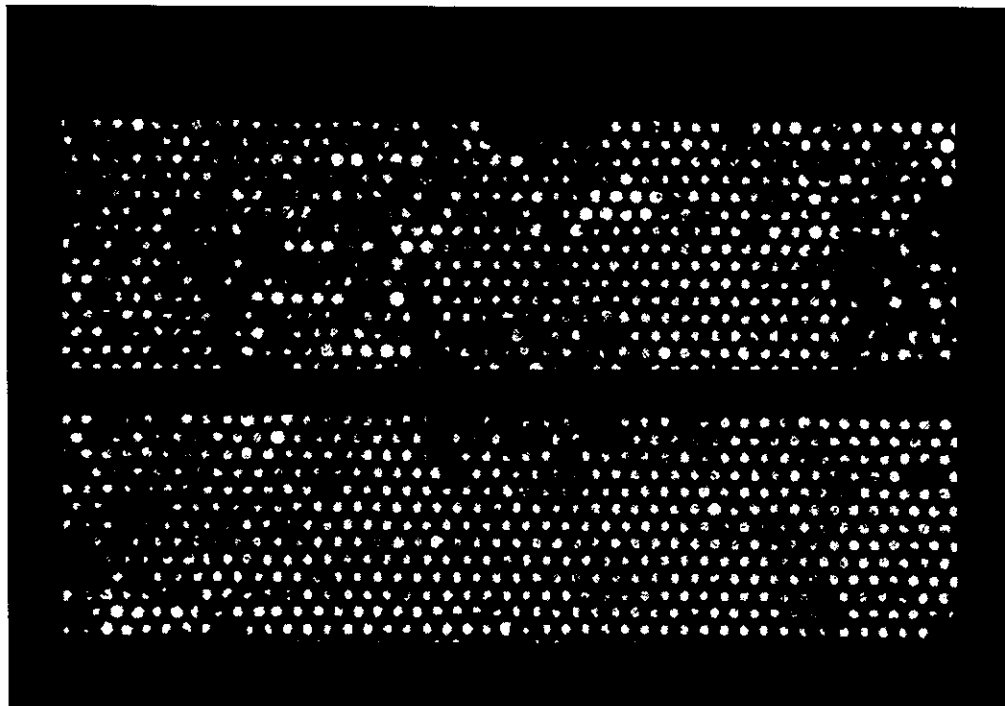
Figure 6: The starboard side screen was shot with high contrast for image analysis.
